## CONTAMINATION AND ITS AVOIDANCE

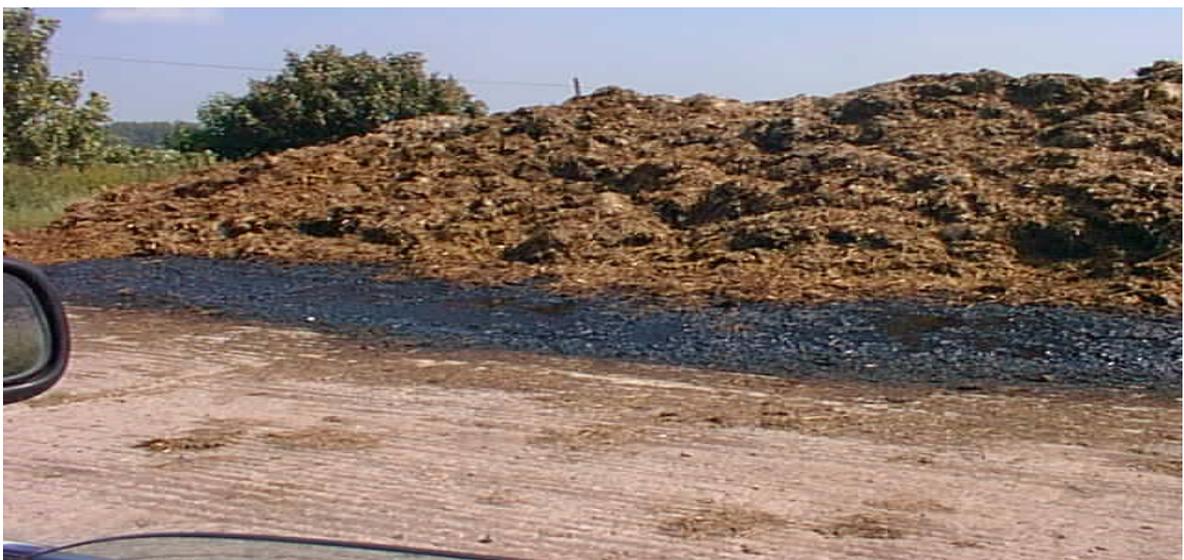
Possible source of contamination – Leachate from Silage

The well head in was in a field adjacent to cattle barns with only the wooden pallet as protection from animals walking over the lid.

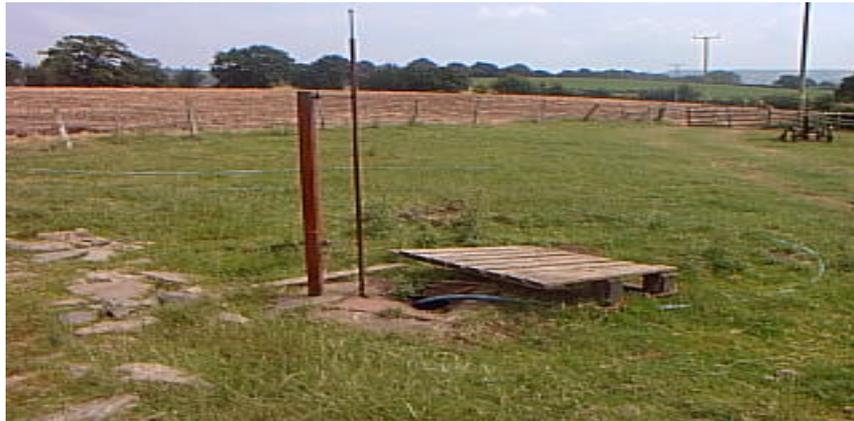
Figure 30

Vulnerable well abstraction

The above pictures illustrate the potential risks of penetration of surface water due to the poor design and maintenance of capping of wells.

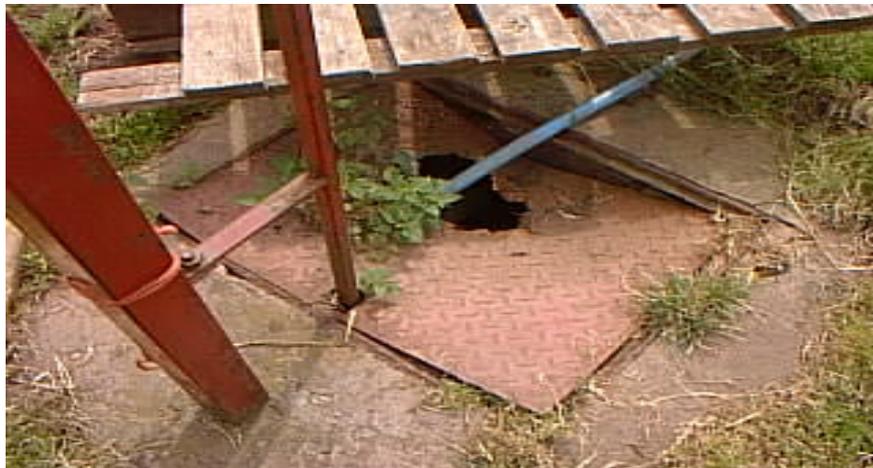
Vulnerable well abstraction

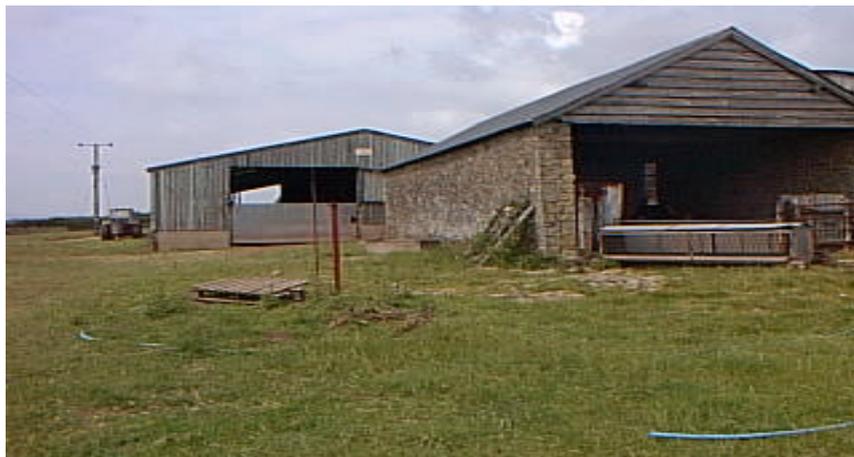
Cattle Barns

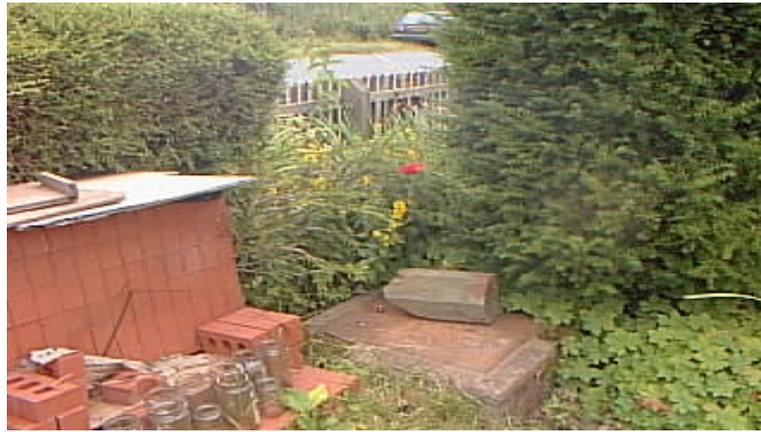
Previously well-constructed Abstraction Point

Illustrates an abstraction which was originally well constructed, but the accumulation of vegetation and stored bricks has increased the risk of contamination.

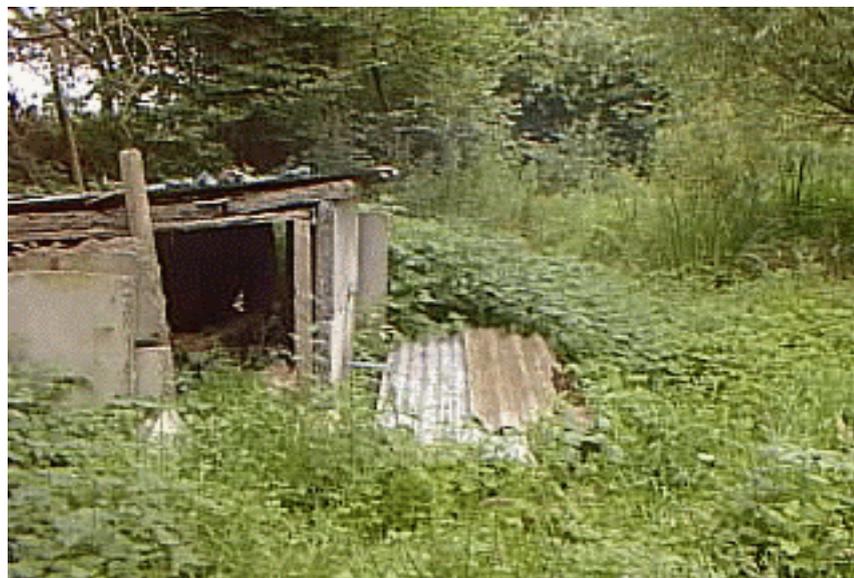
Poorly maintained Enclosure
