Hereford city defences a conservation management plan

Part two: Gazetteer

Herefordshire Archaeology Report 292

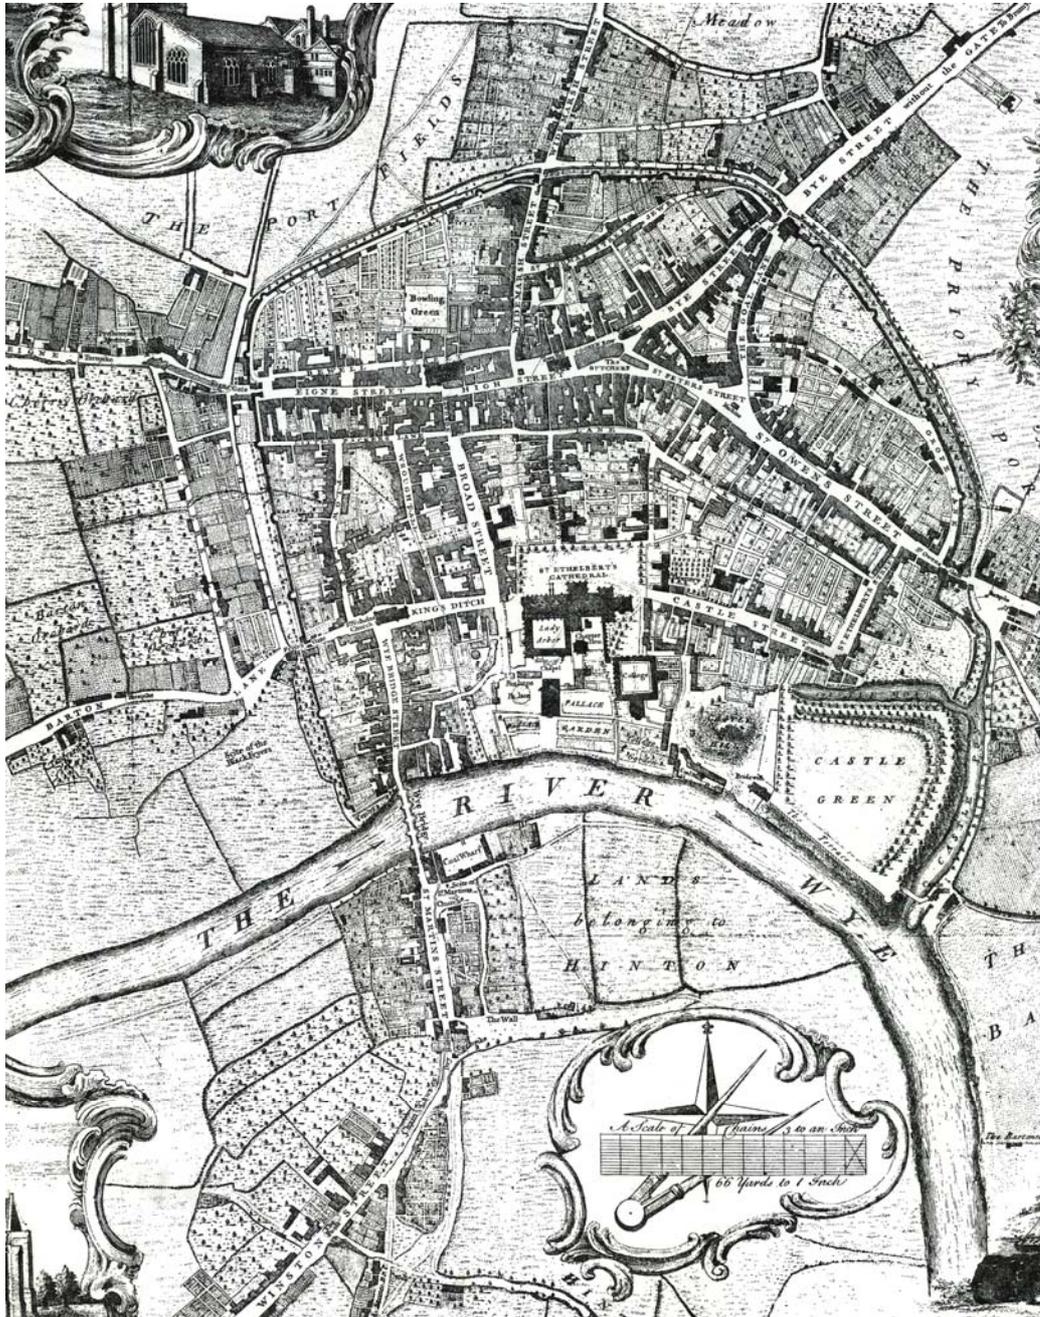
The central portion of Isaac Taylor's map of Hereford in 1757. The medieval city defences are still intact, at least in plan. The Bishop's Meadow Row Ditch appears just above the cartouche containing the scale bar. Taylor was an experienced and reputable urban cartographer and this map is regarded as being generally reliable and accurate for the period

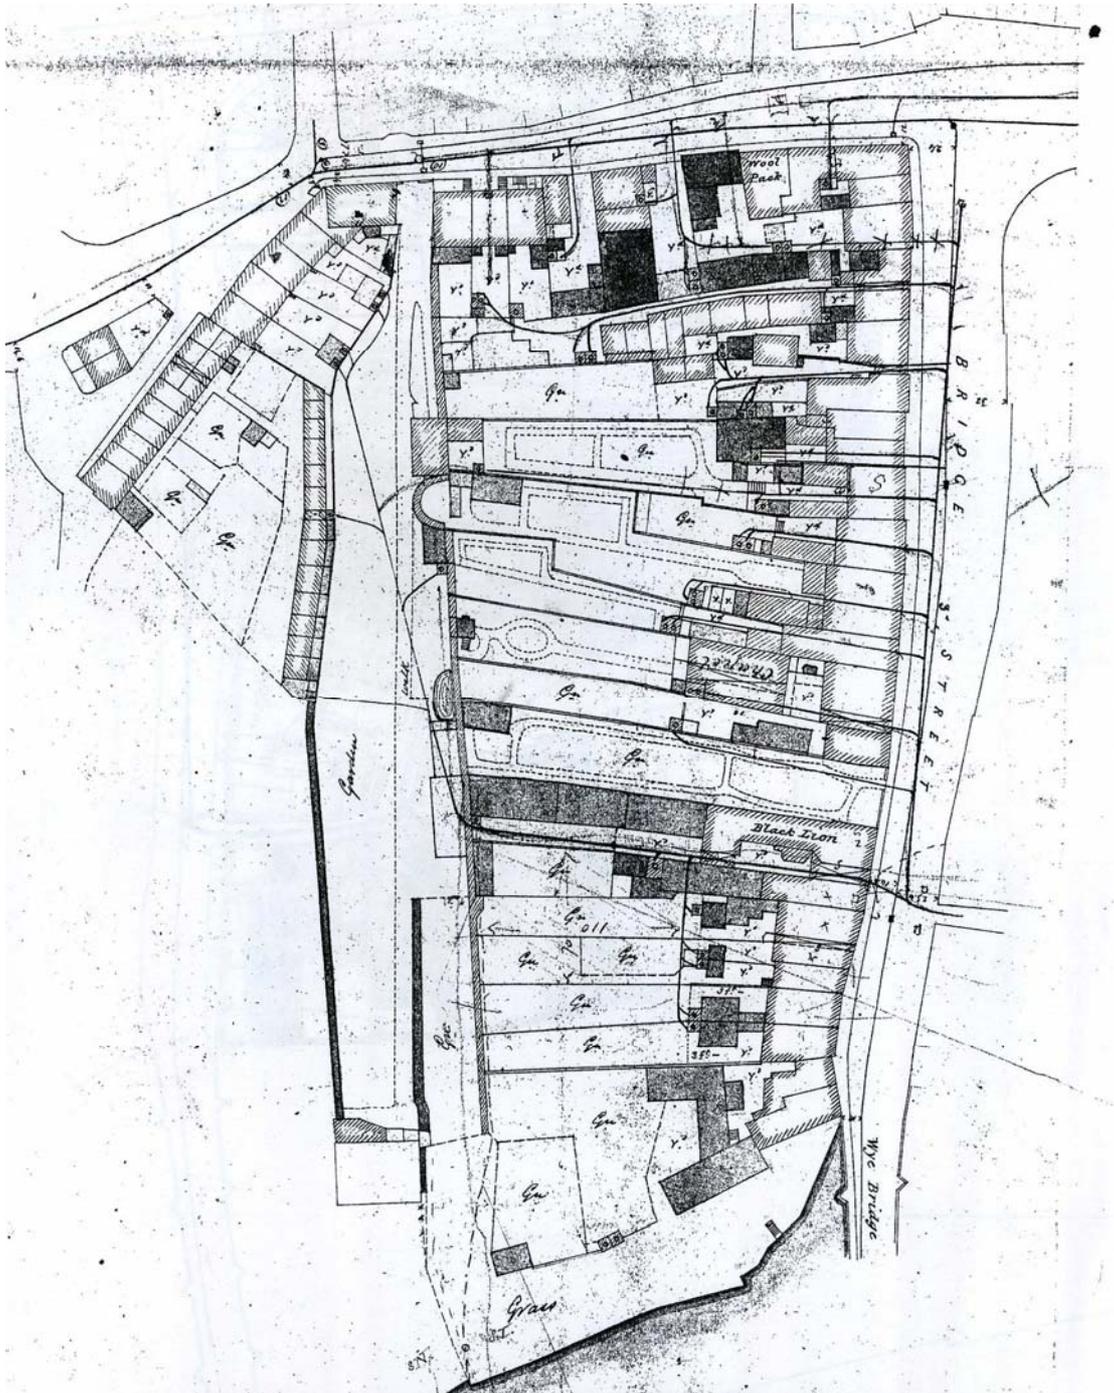
Timothy Curley's 1859 MS plan of the Bridge Street/St Nicholas Street area

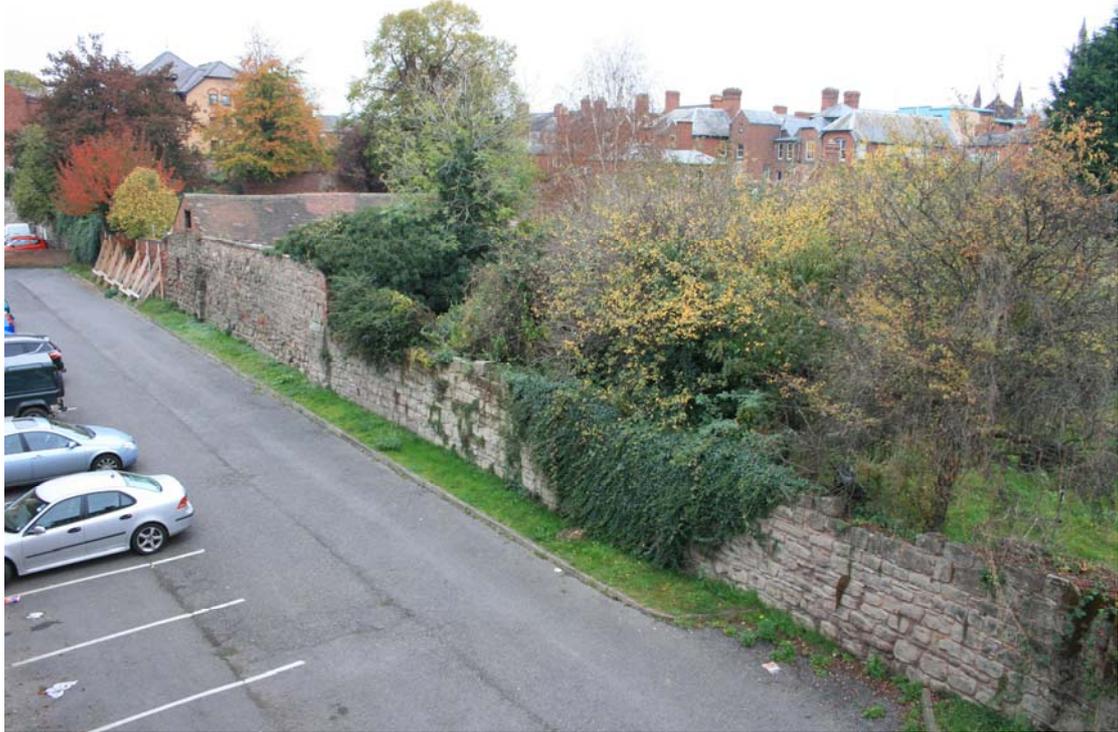
General view of the south end of section 1

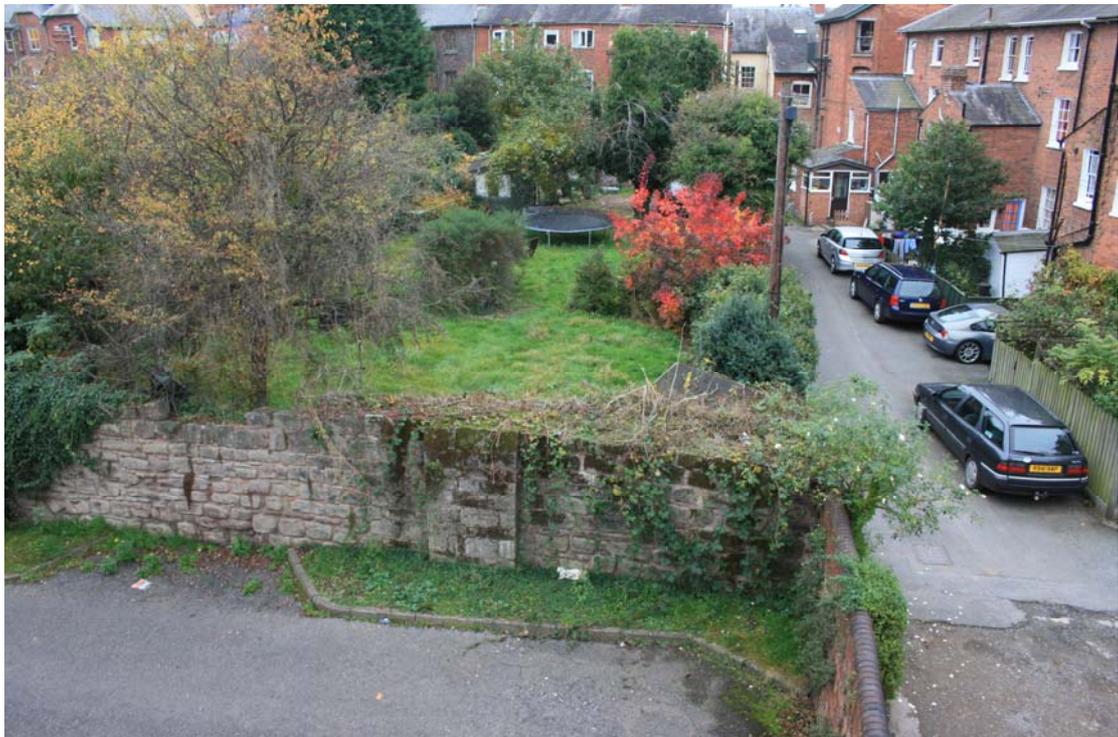
The first (most southerly) section of the wall (43811) stands to a height of 2.2m/eight courses and is composed of large squared rubble sandstone blocks, roughly square in their proportions, well coursed, with levelling-up courses of much smaller, flattish stones. Coursed in with this fabric are ashlar-built clasping buttresses 1.3m to 1.4m wide, their tops inclined back to the main wall face about 2m-2.5m above external ground level. At its south end the wall appears to retain its full thickness whereas further north it is reduced to a single stone thick, the outer face having been retained while the core and inner face have been robbed away.

The southern termination of the free-standing buttressed stretch of section 1 behind Wye Terrace

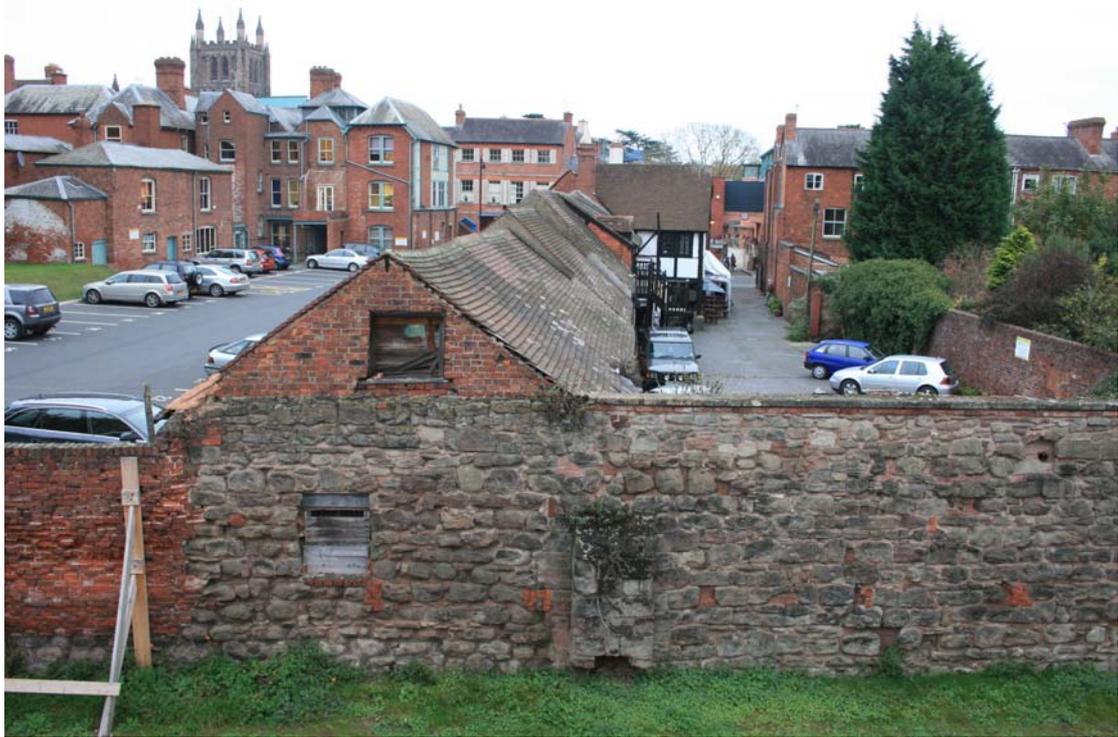
In the adjacent section of wall, at the rear of the Black Lion pub, fabric with the same characteristics and coursing continues, though here it survives c. 4.5m/14 courses high, with some rebuilding of the topmost metre and a single brick top course under flat coping stones. The wall is surmounted by the brick gable of the rear range of buildings extending back from the pub and a window has been inserted through the wall below. The inner (east) face of the wall is contained within the pub's outbuildings and consists of uncoursed small rubble with many evident rebuilds.

The section 1 wall at the rear of the Black Lion pub on Bridge Street

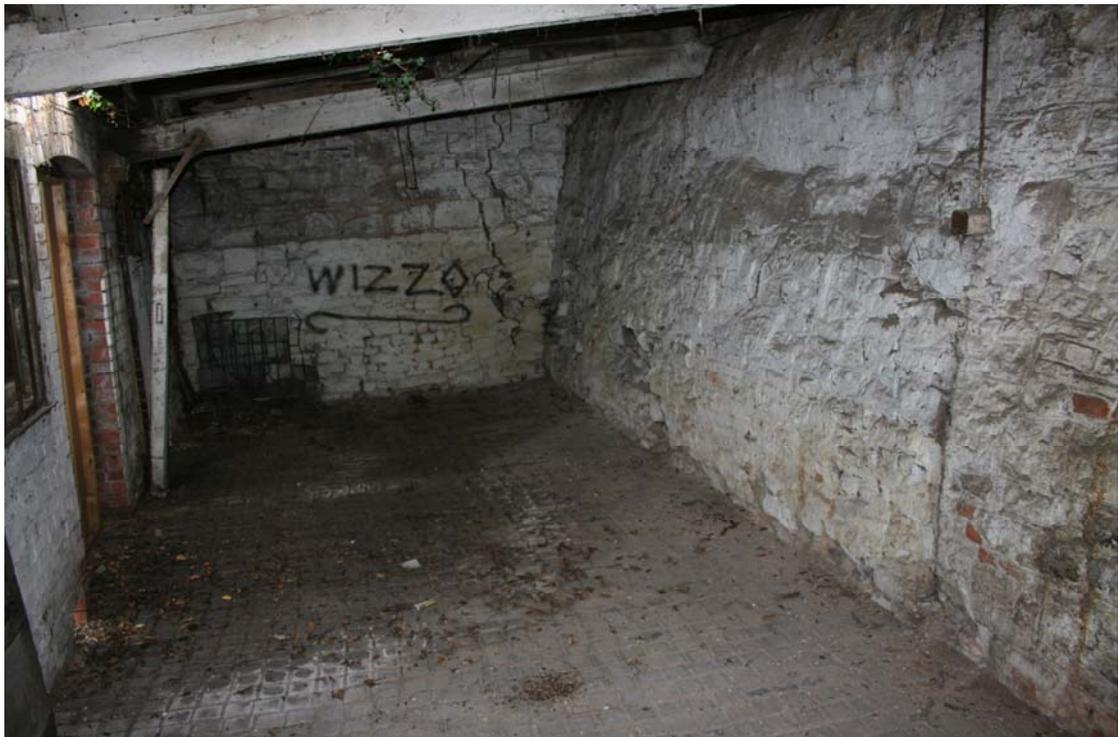
The interior face of the wall within the Black Lion's outbuildings, built along the wall, is currently neglected within the empty outbuildings, parts of which are in poor condition. The owners should be encouraged to make more of the city wall as a historic feature of the property

Interior (east) face of the wall in the Black Lion outbuildings

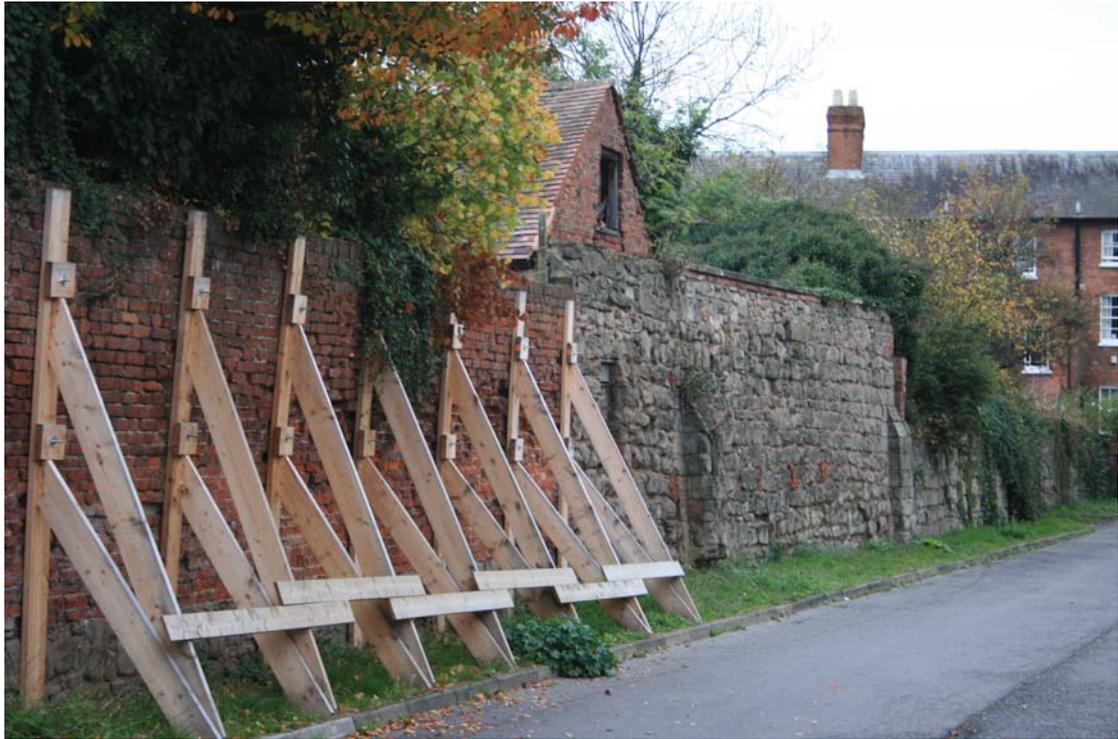
A substantial section of superincumbent, badly eroded brickwork on the wall line between the bastion and the Black Lion has developed a substantial outward lean and is being held up by temporary and unsightly timber shores to prevent its collapse: this is now (September 2011) about to be taken down under archaeological supervision and rebuilt. Further north, adjacent to the bastion, there are substantial mats of ivy on the wall top potentially masking loose masonry. Although not presenting such an immediate hazard, mature trees growing just within the wall in this area will, in the long term, cause root damage to the monument. Ivy and tree growth will also shortly (September 2011) be addressed.

The failed brickwork stretch of wall immediately north of the Black Lion plot, prior to repairs

- Repairs to the failing brickwork, and control of ivy and tree growth is about to be addressed on this section (late 2011)
- Although this part of the wall receives a fair amount of attention from visitors, particularly those using the car park at its foot, there is presently no interpretation on site, nor guidance to seek out this section in any wider-ranging visitor literature. Carefully designed sympathetic on-site interpretation is needed, together with referencing within city-centre visitor guides.

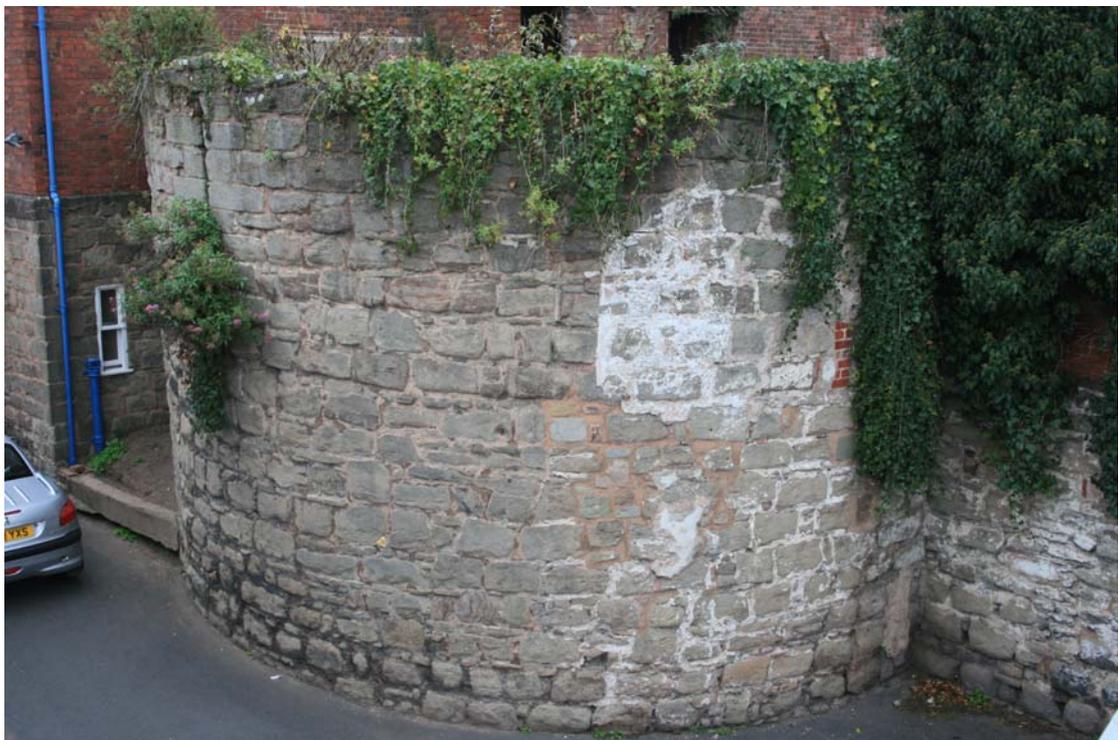
The bastion (B2) (20245). Semi-circular in plan, with loops at present parapet height surviving or partly surviving on three sides, this structure survives to a height of 5.5m above external ground level. The wall fabric is the same as the adjacent wall section – large squared rubble blocks with intermediate levelling-up courses – and appears to be primary medieval work.

The bastion B2 is mostly in sound condition though at least one substantial crack has become apparent in the NW-facing upper courses. Undergrowth within the bastion interior and inside the wall has recently been removed. The wall in this section is elsewhere generally in a relatively good state of repair with only limited vegetation growth in some joints in the wall face and a mat of ivy overhanging the southern section of the wall.

Bastion 2, adjoining the south side of the Greyfriars Surgery.

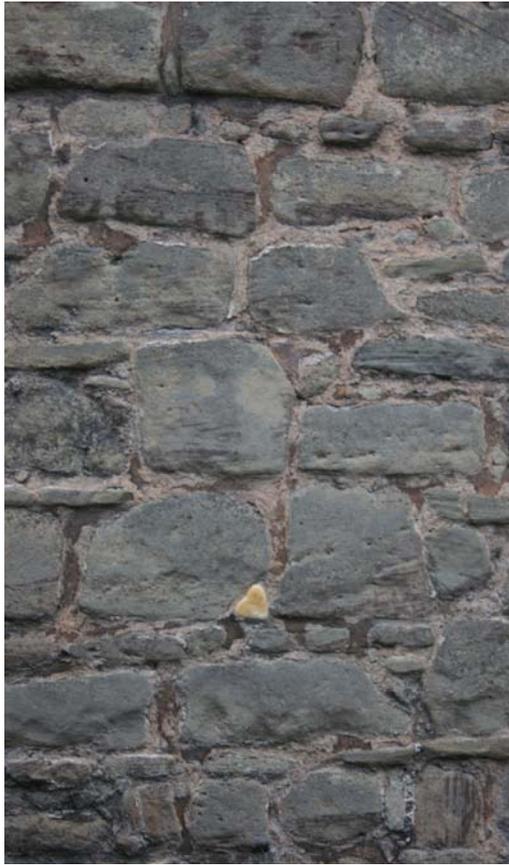
Detail of the suggested 'primary' build character masonry, seen in section 1 and elsewhere, consisting of large square blocks with short, intermittent levelling-up courses

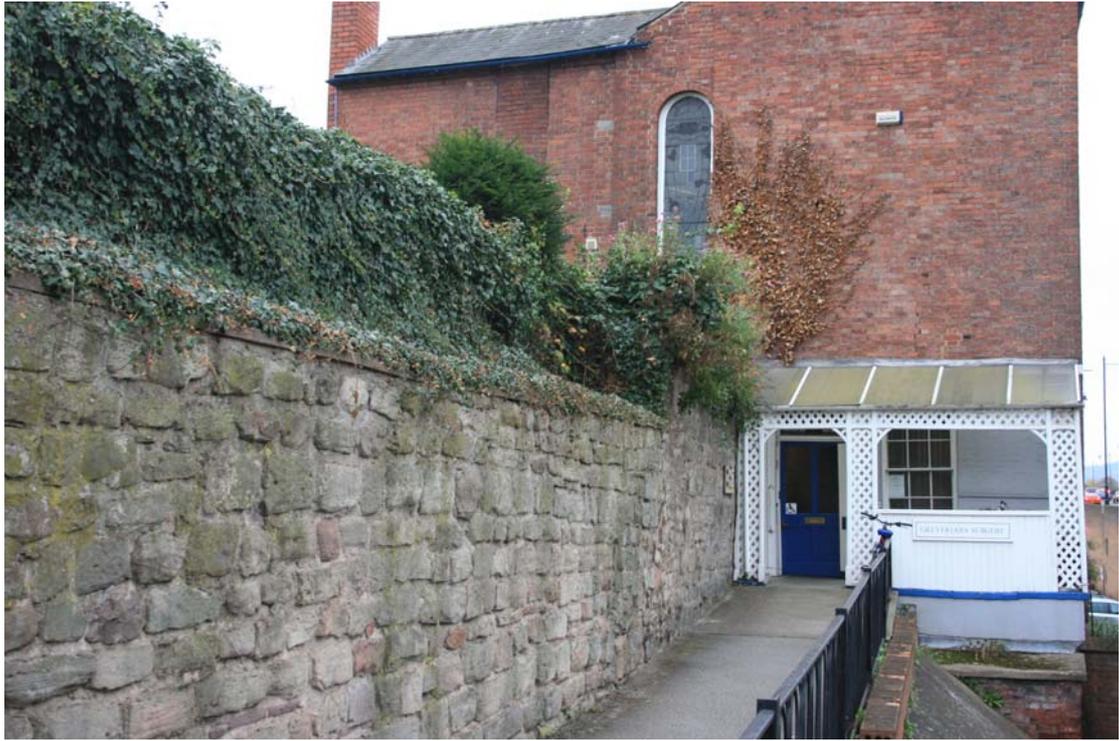
A 24m long stretch of city wall fabric (43813) survives here as a 2m-3m high retaining wall bounding the entrance path to the Greyfriars Surgery from the north (St Nicholas Street). The wall here is built of roughly coursed squared rubble, mostly of a fairly uniform size (average c.300 x 200mm blocks). The larger squared blocks characteristic of the wall south of the surgery are here present only at the south end, close to the surgery. A crack, and a slight change in alignment, about 10m north of the surgery suggests a rebuild, or the junction between different rebuilds, between the south end, which stands c.3m high, and the north end, c.2m high. Further masonry may survive within the surgery building though its interior has not been examined.

The surviving length of wall is in relatively sound condition. The lack of any interpretation (other than a small plaque on the wall on the opposite side of St Nicholas Street) is an issue that should be addressed.

Section 2: the wall on the approach to the Greyfriars Surgery

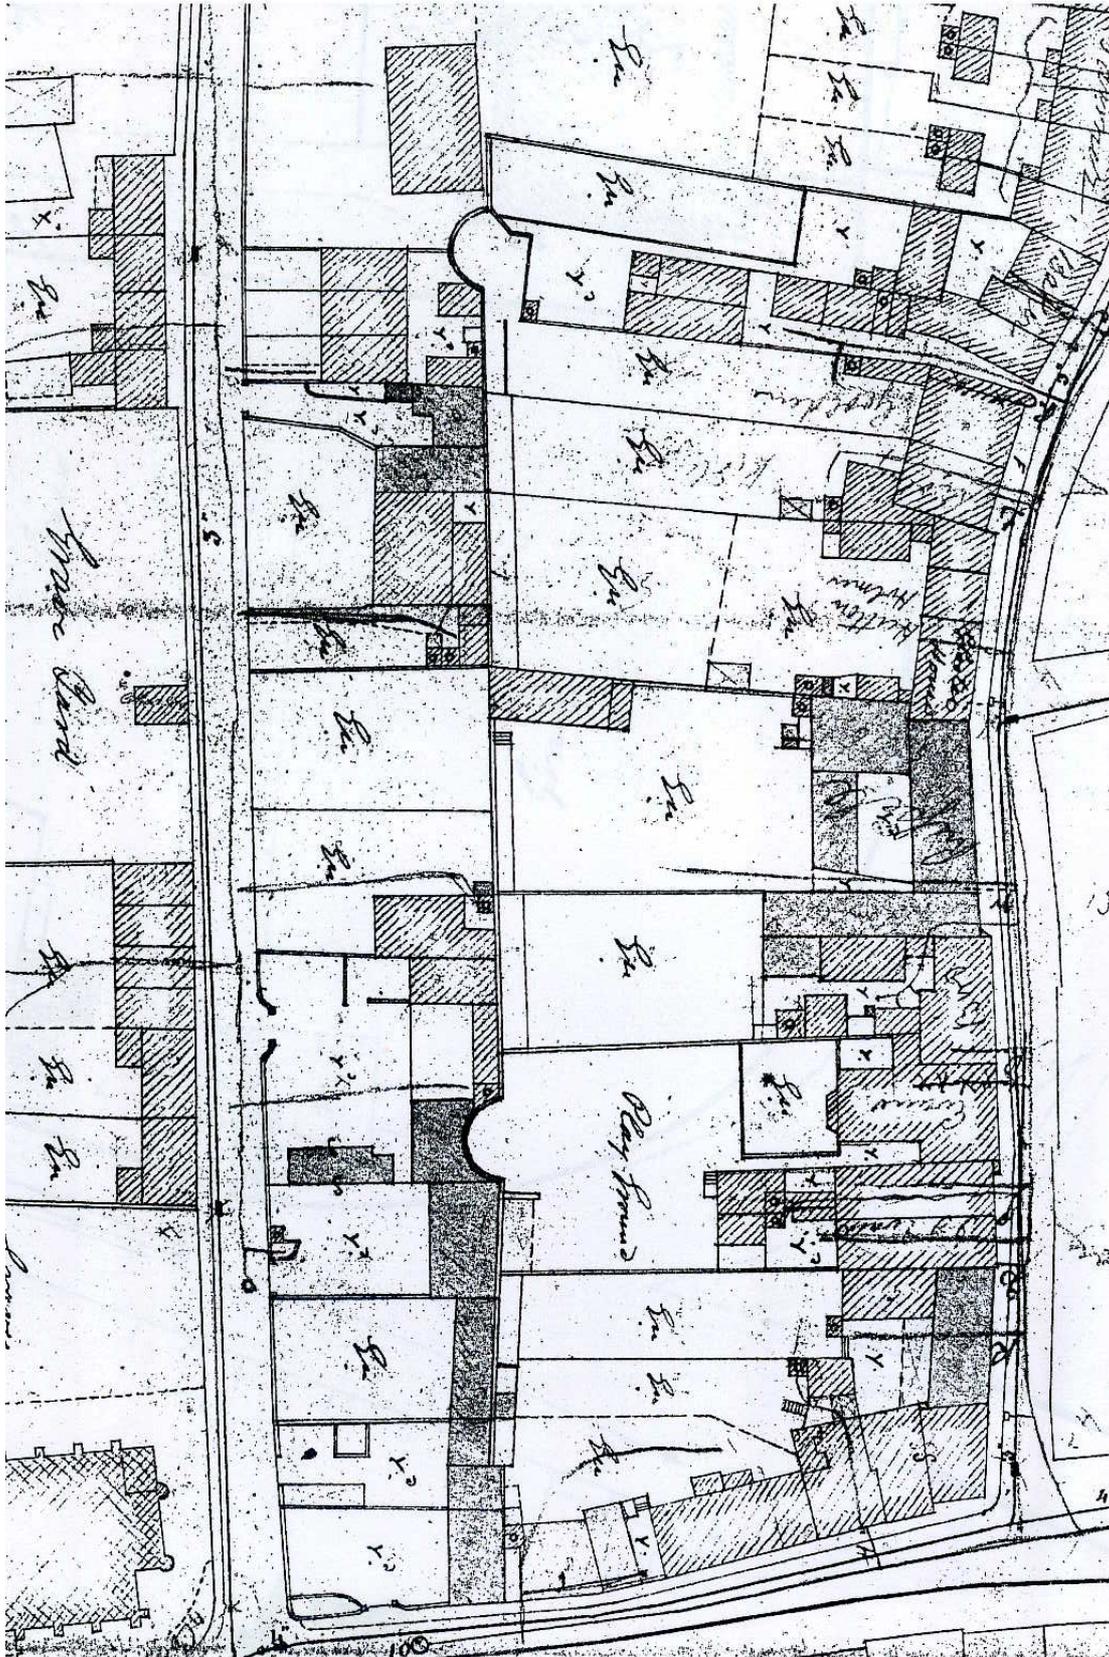
Section 3 of the city wall as surveyed by Timothy Curley for his map of 1858. Both bastion B3 and B4 survived though the outer face of the wall was fast becoming encumbered with buildings. One plot north of B4 the wall had already been removed (see section 4).

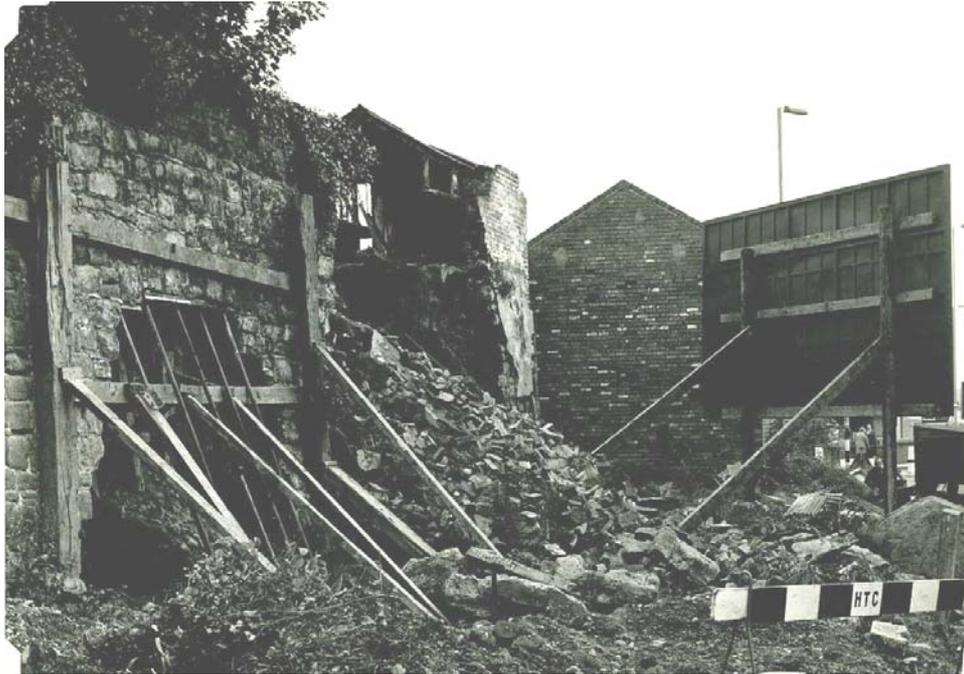
Demolition of the Victoria Street properties in the 1960s built against the city wall was problematic, in that the masonry was in some areas in very poor condition, leading to localised collapses. From one such collapse near St Nicholas Street (possibly that in the photograph reproduced below) Graham Roberts relates that several 10lb iron cannonballs were recovered, almost certainly lodged in the rampart core since the siege of 1645 when the Friars Gate came under intensive bombardment. One of the cannonballs was treated by a museum conservator and built back into the wall during the subsequent restoration work (Roberts 2001, 71). In recent years this cannonball dropped out of the masonry, though it was handed in to Hereford Museum and is now on display there. The cannonball in the wall has however become a fixture in local folklore and is fondly remembered by residents as a dramatic, if not wholly authentic, relic of the Civil Wars.

The south end of section 3 looking south. Photograph of September 1968 showing collapses immediately north of the electricity sub-station (Hereford City Council contract photographs file)

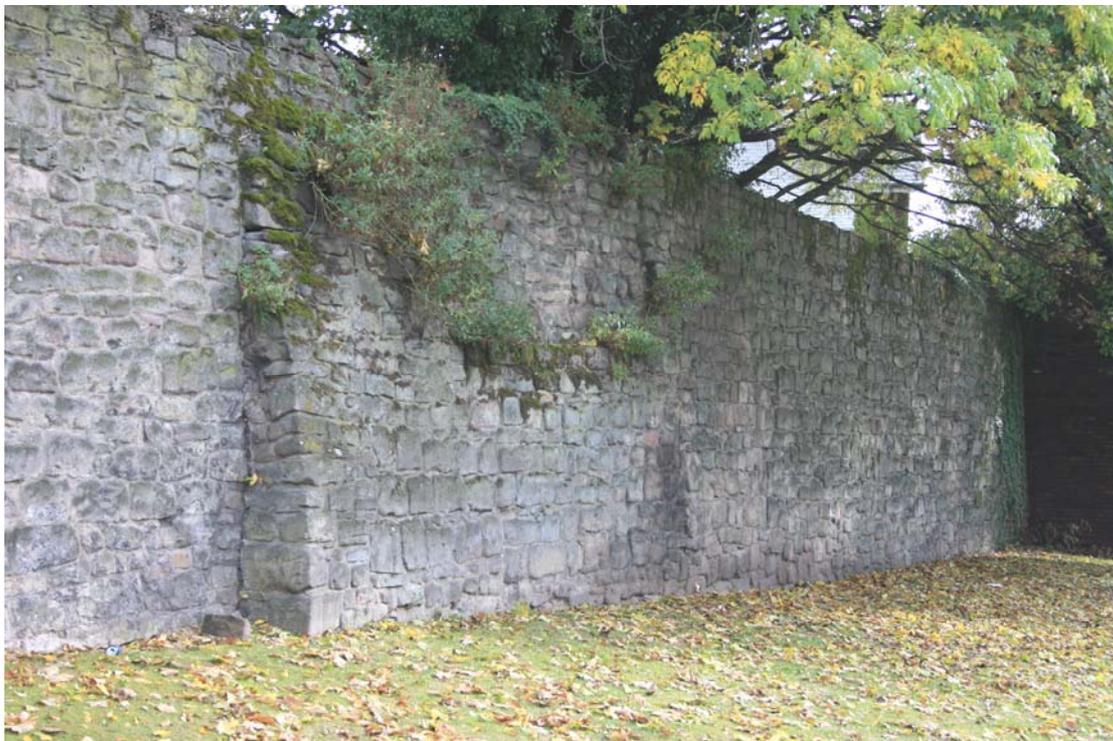
The same view in 2009. The Civil War cannonball found embedded in the rampart material behind was built into the masonry c. 3 metres above ground level just short of the electricity sub-station (right)

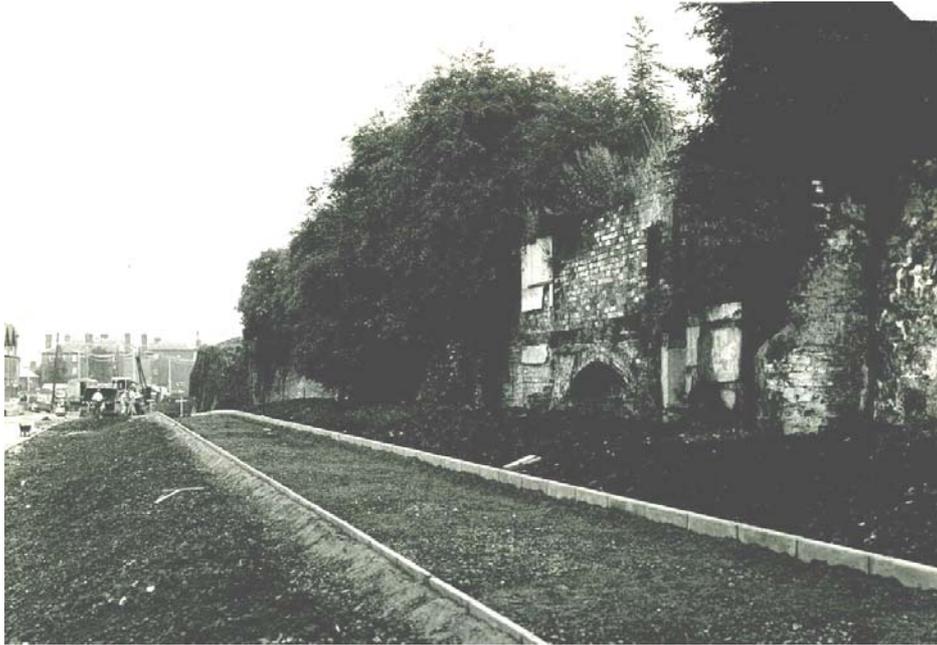
General view of section 3 looking north. Photograph of August 1968 showing substantial brickwork section (including arch) replaced in sandstone the following year (Hereford City Council, contract photographs file)

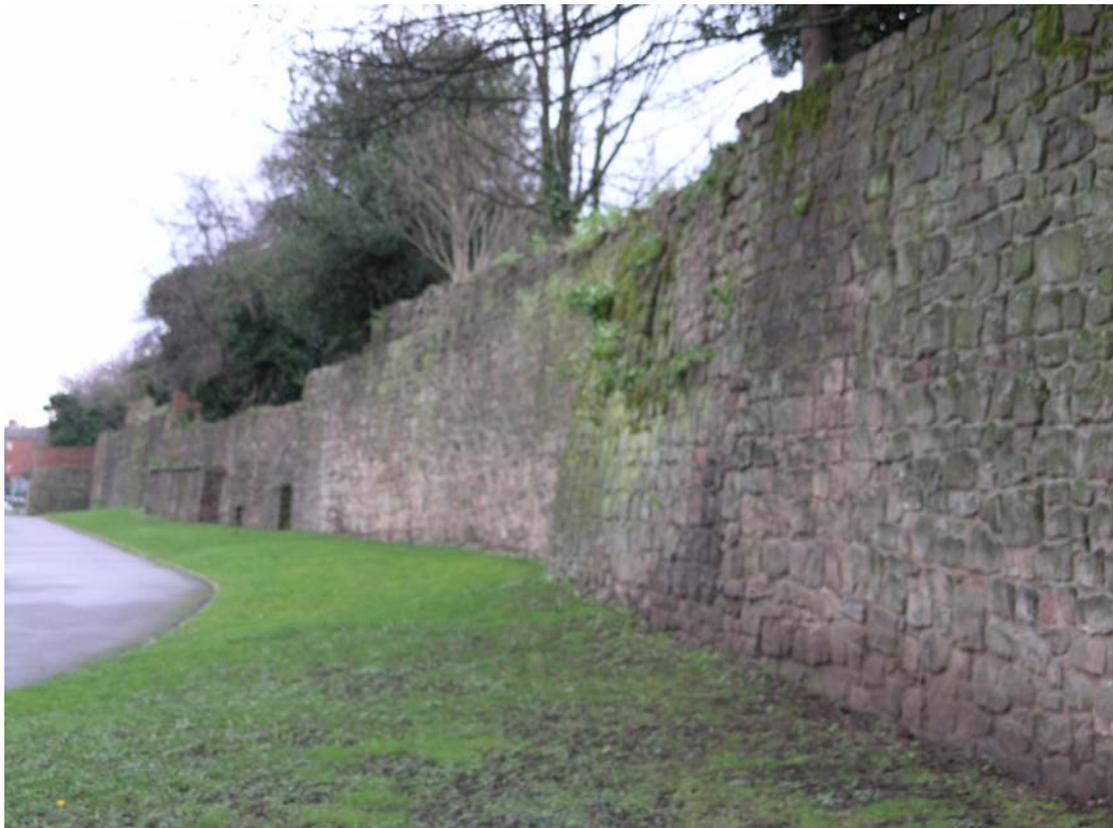
The outer face of the wall was comprehensively restored and re-pointed, and some sections completely rebuilt, in 1968-9. The pointing here is generally in good condition with occasional vegetation growth on the wall face, though mats of ivy hang down from the wall top in some places, particularly at the north end adjacent to bastion B4. Some cracking is apparent, generally at junctions between rebuilds and there are signs of outward movement in the masonry of the bastion. Where the inner face of the wall is visible above ground- or rampart level this is in some areas in poorer condition and the concrete capping of the wall (and offsets) at the south end is parting company from the fabric beneath.

The same view in 2008. Apart from the absence of the brickwork features seen above, the extent of the 1968-9 reconstruction work is not obvious

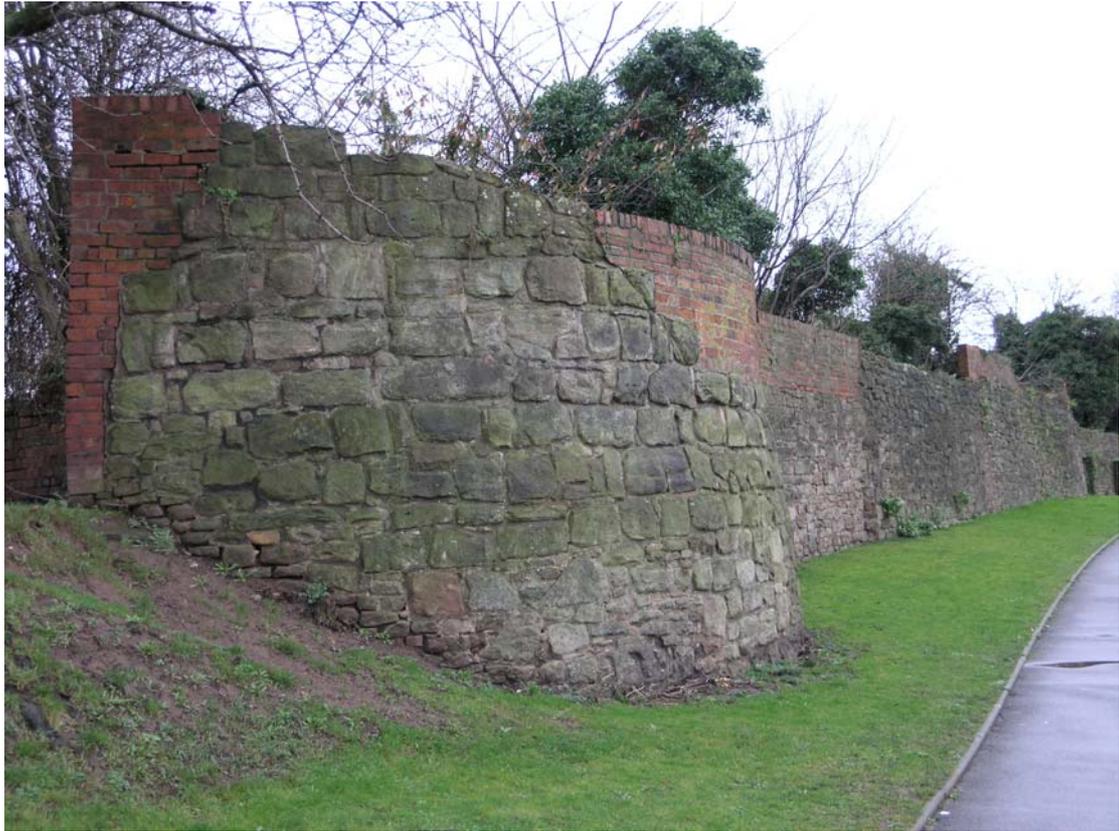
General view of section 3 looking south from Bastion 4

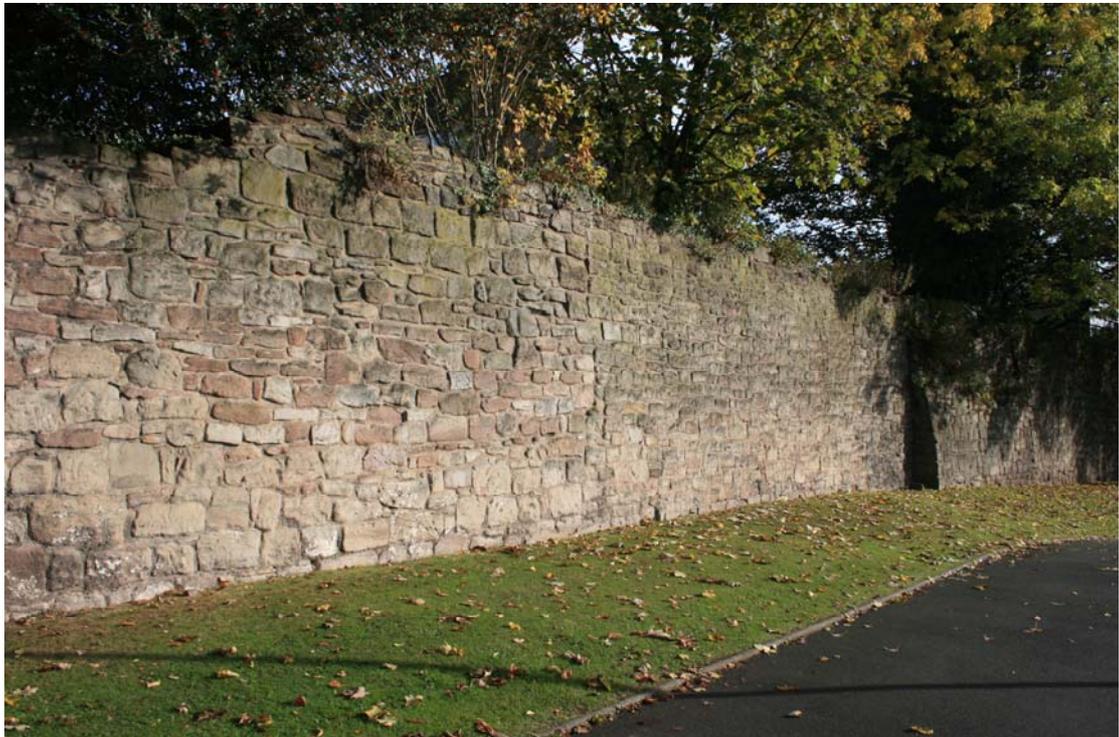
This stretch terminates at a diagonal crack marking the commencement of a different build, characterised by much better coursing, and more squared rubble with small flat stones laid in places as levelling-up courses. 3-4m further north a vertical joint indicates the commencement of a different build c.7m long, characterised by a lower section of wall with large squarish blocks and levelling-up courses and an upper section (set back) of roughly coursed smaller blocks. A straight joint discloses one side of a former opening. To the north three or four larger stones with a battered face may be a remnant of a

Different builds in the masonry of section 3 on the exterior face of the Berrington Street Job Centre stretch

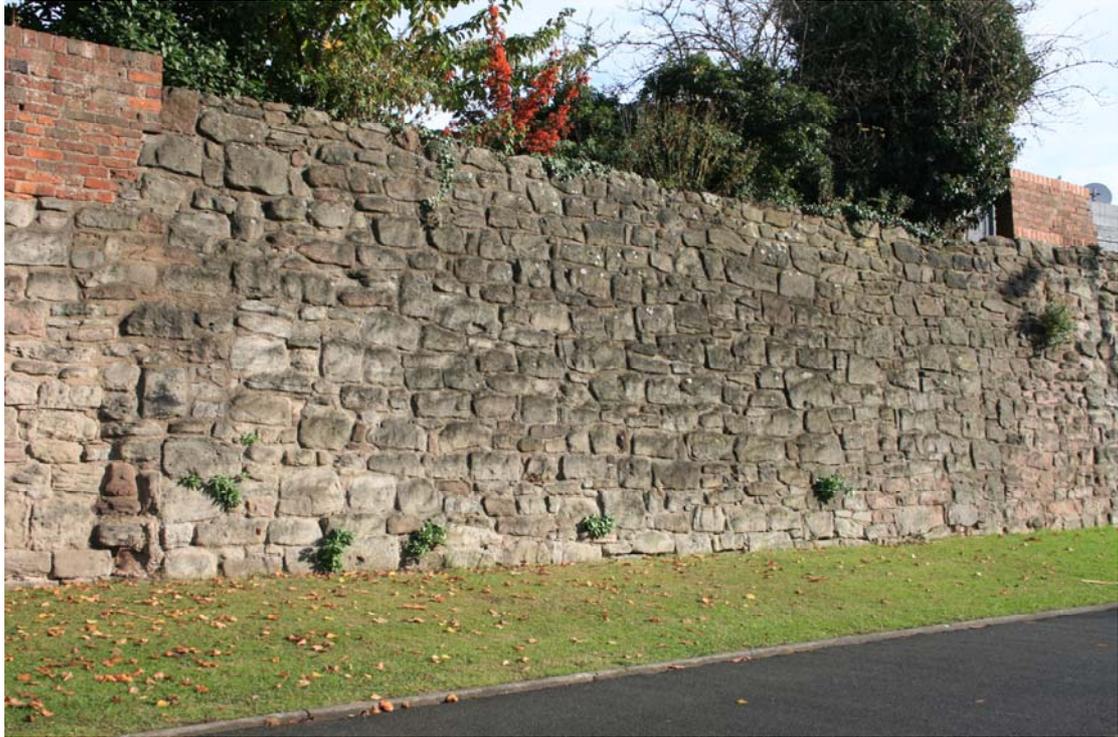
Outer face masonry of section 3 opposite the Blue Rooms plot

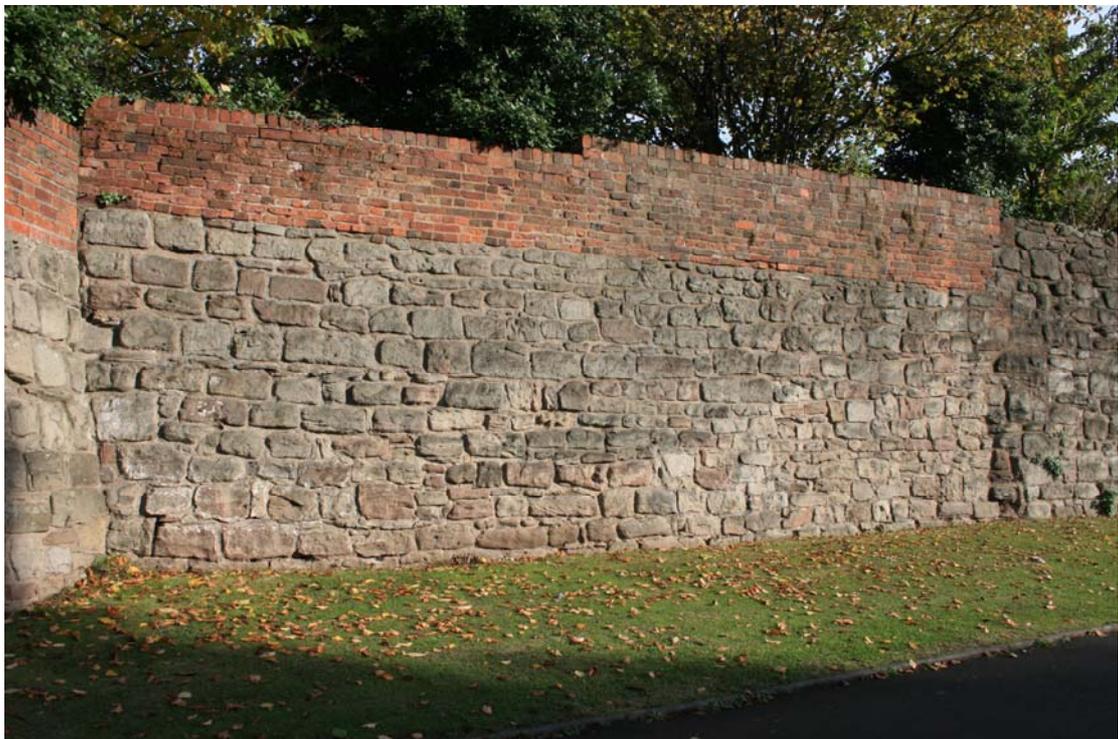
Outer face masonry of section 3 immediately south of Bastion 4

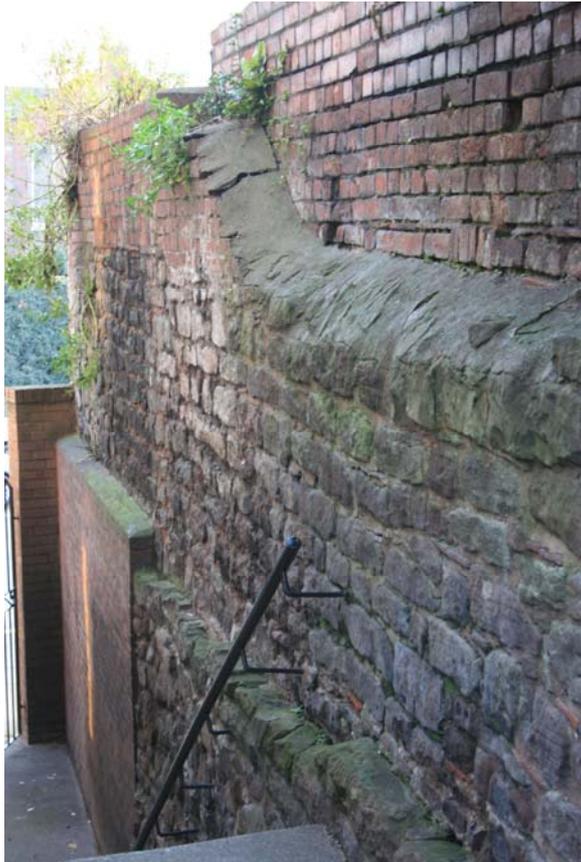
Interior face masonry of section 3, south end, with the descent from rampart-top level down to St Nicholas Street

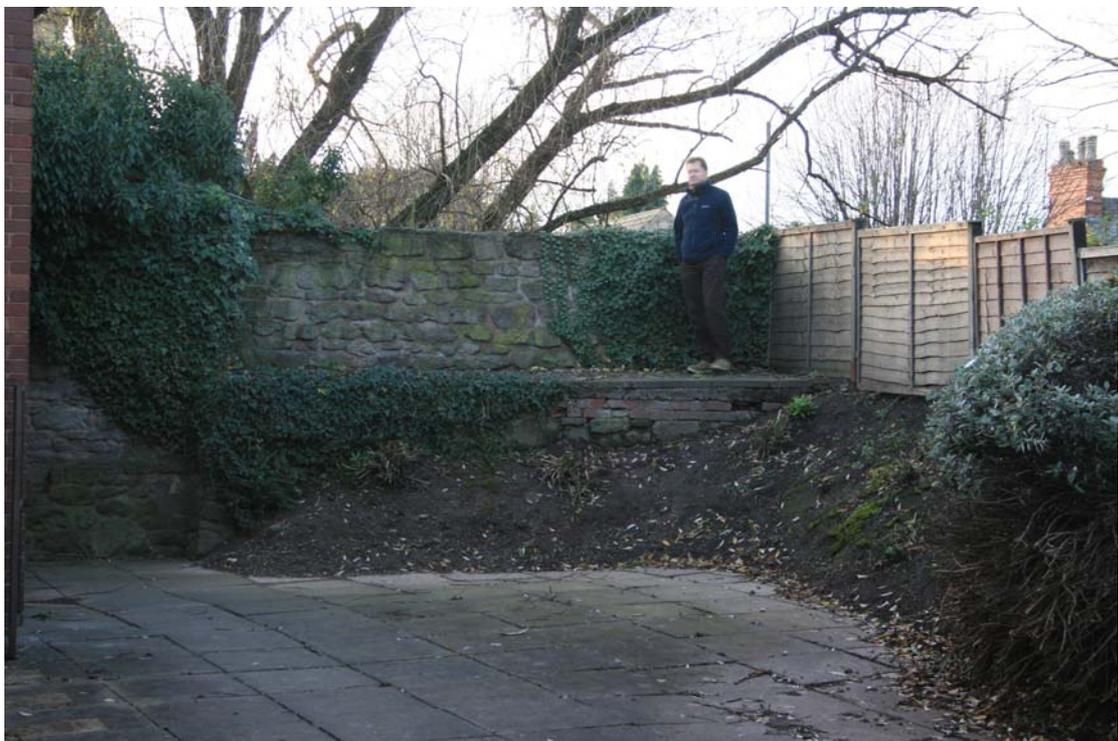
Interior at rampart level behind offices/houses on St Nicholas Street. This is the area of the collapsed section north of the sub-station, seen above in 1968

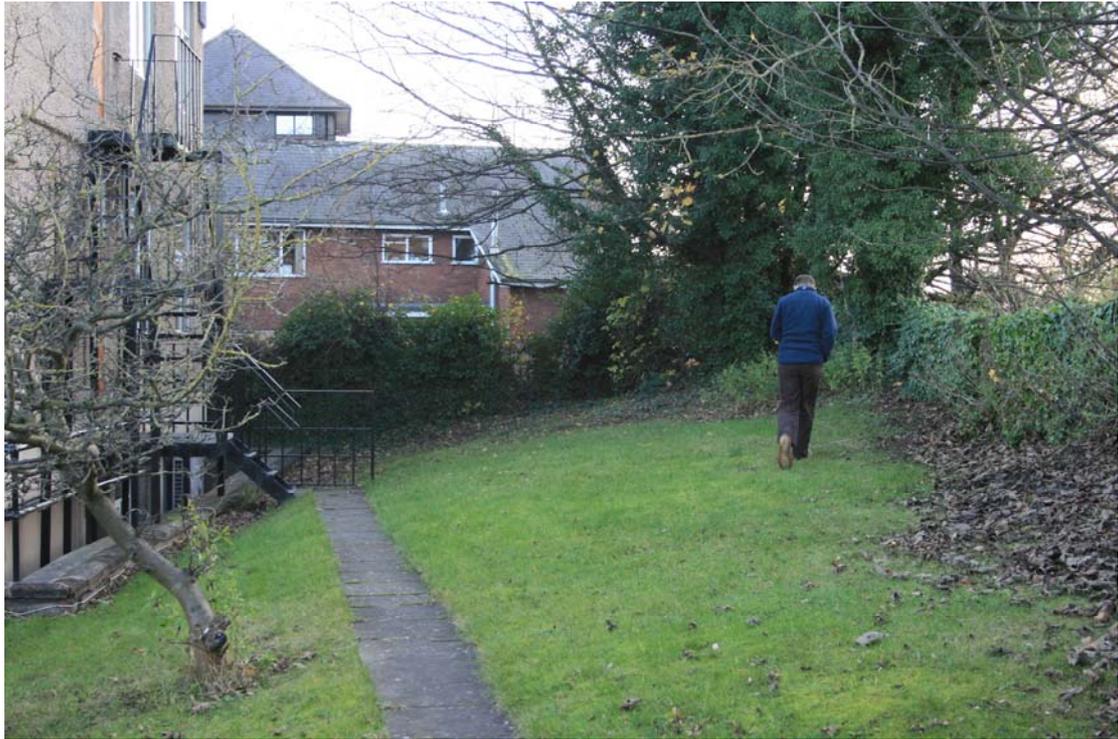
Rampart-top/parapet level on the Berrington Street Job Centre site, looking south

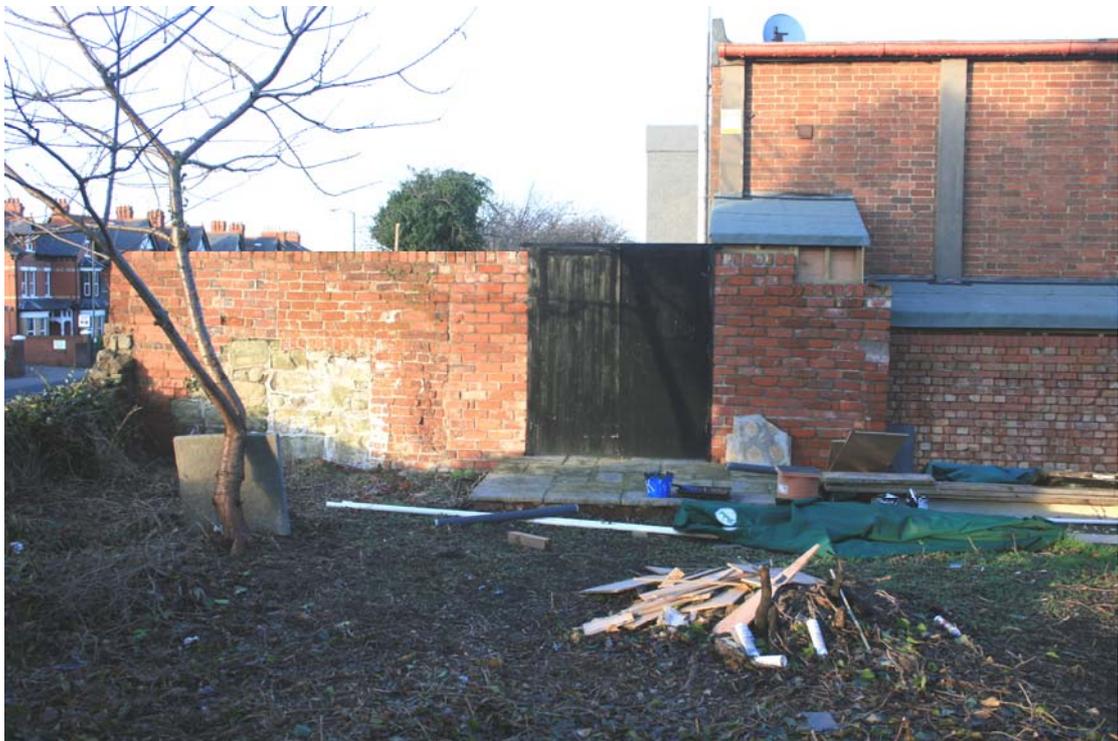
Rampart-top/parapet level at the north end of the Job Centre plot, looking north towards the boundary of the Blue Rooms plot
