Hereford city defences a conservation management plan

Part two: Gazetteer

Herefordshire Archaeology Report 292

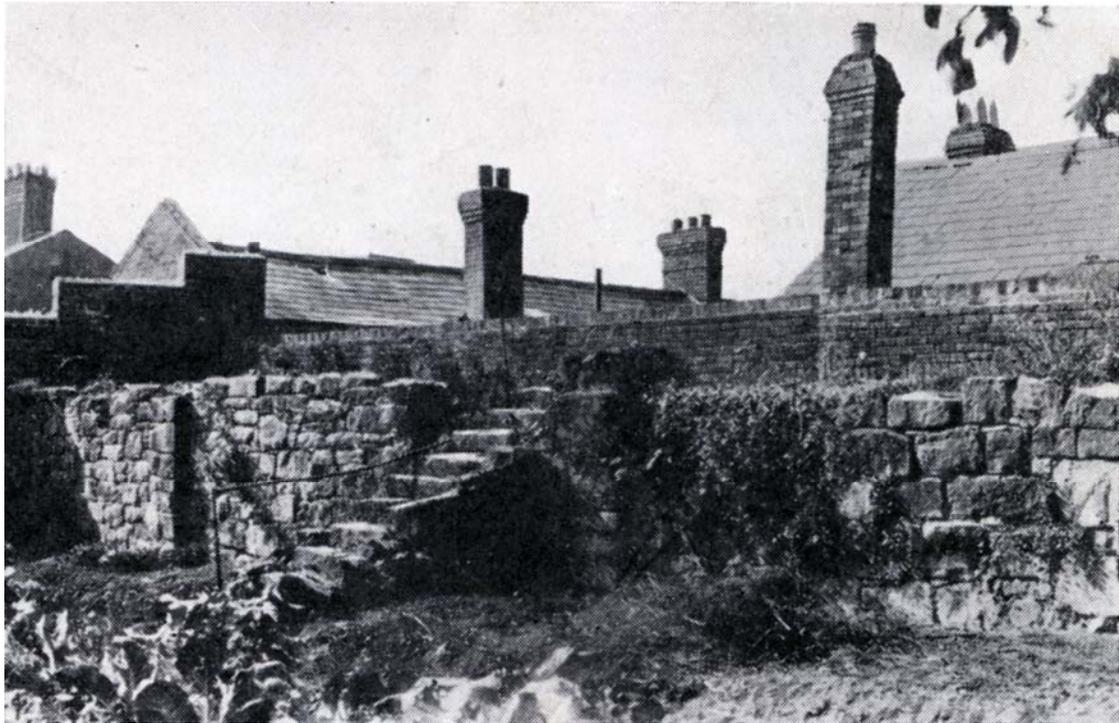
View of c.1900 probably showing buttressed interior face of the wall on the Blue Rooms nightclub plot (south of Job Centre) (courtesy Derek Foxtan)

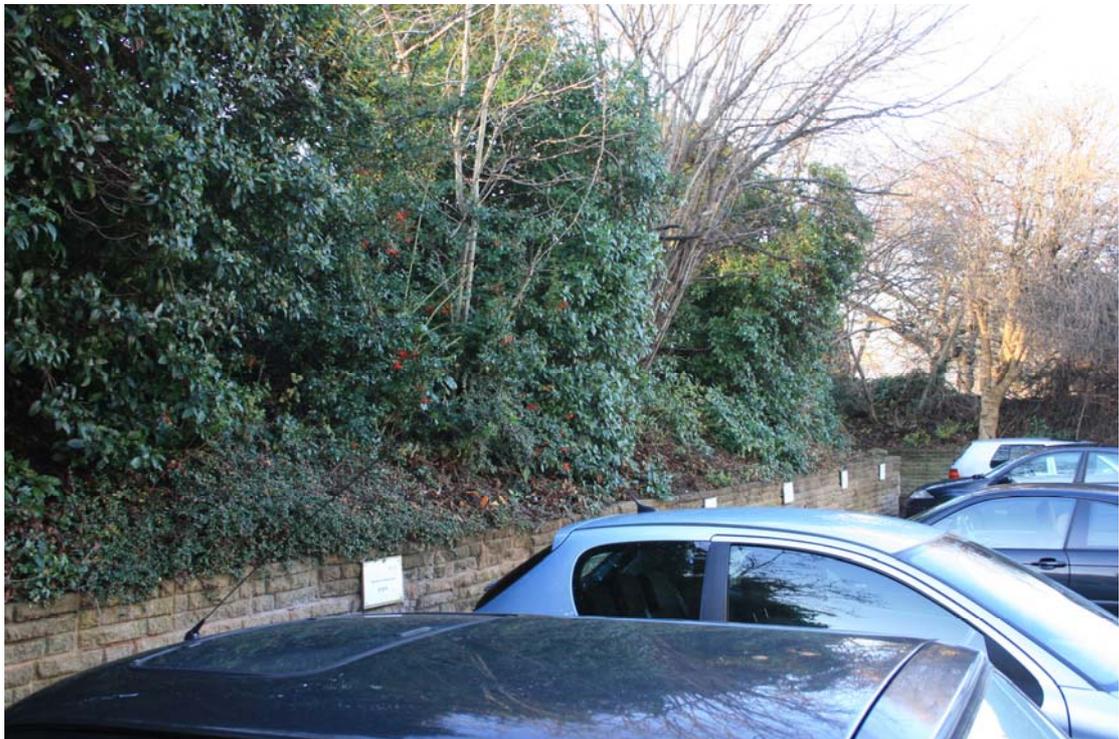
In the adjoining, northernmost, plot (Kemble Housing Association), the old retaining wall behind the rampart has been replaced by a modern brick version cut further into the rampart at 1m to 2m behind the city wall parapet. The stretch ends at bastion B4, described above, the interior of which can best be summarised as being in an overgrown and ruinous condition.

Interior face of the rampart on the Kemble Housing Association plot, looking north towards Bastion 4. The wall parapet is concealed by the dense undergrowth

- Management agreements should be sought with the owners of the Job Centre and Kemble Housing Association plots for the reduction of vegetation on the ramparts; consideration should be given to the felling of mature trees whose root systems are likely to be compromising the monument.

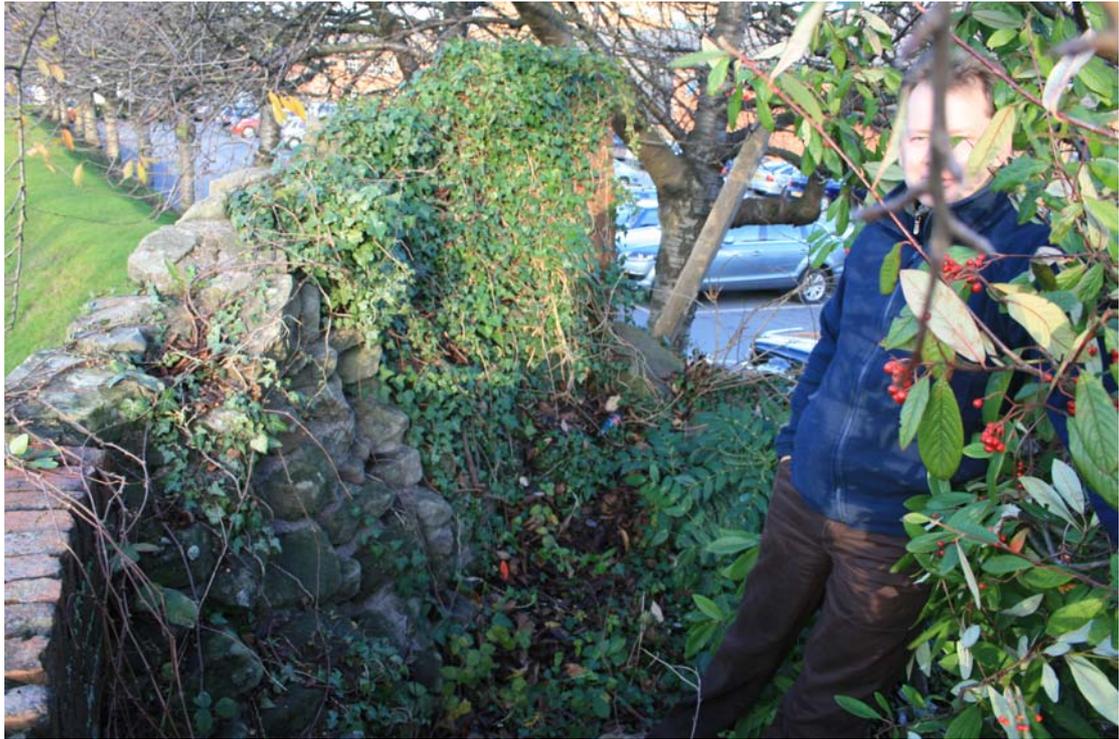
Bastion 4 interior, looking north at rampart-top level. The figure in the foreground is parting the undergrowth to allow a clearer view

- Consideration should be given to the restoration of bastion B4. The immediate imperative would be to rectify the present poor condition of the monument in terms of the parapet masonry/brickwork, the brickwork of the property boundary that runs into the bastion and forms the party wall between the public car-park and the Kemble Housing Association property, and the overgrown interior. A less urgent but arguably equally significant imperative would be to develop the bastion as a feature that is interpreted for visitors, certainly by means of signage in the public car-park but also possibly by means of a lightweight platform in the interior approached via access steps from the public car park .

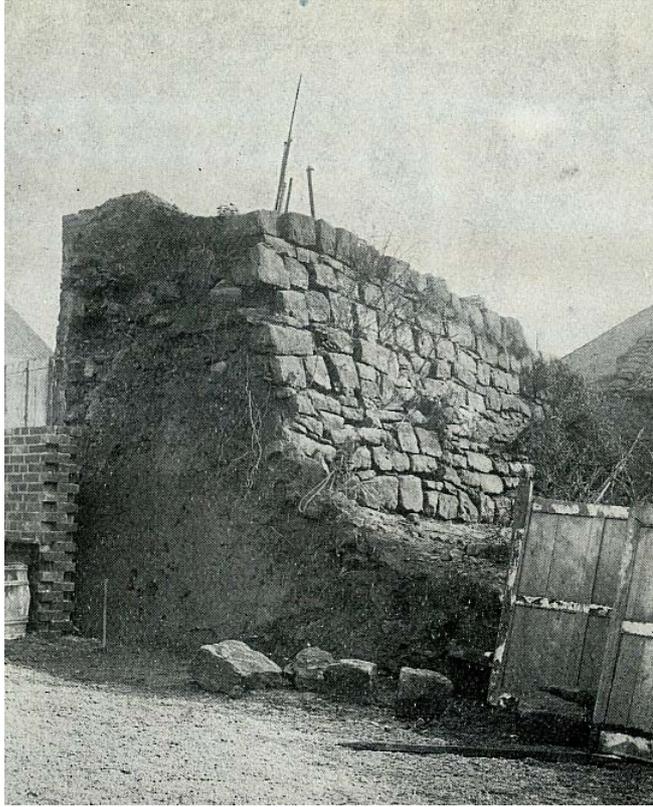
Photograph by Alfred Watkins taken just after the demolition of Bastion 5 and the extension of West Street across its site to connect with Victoria Street.

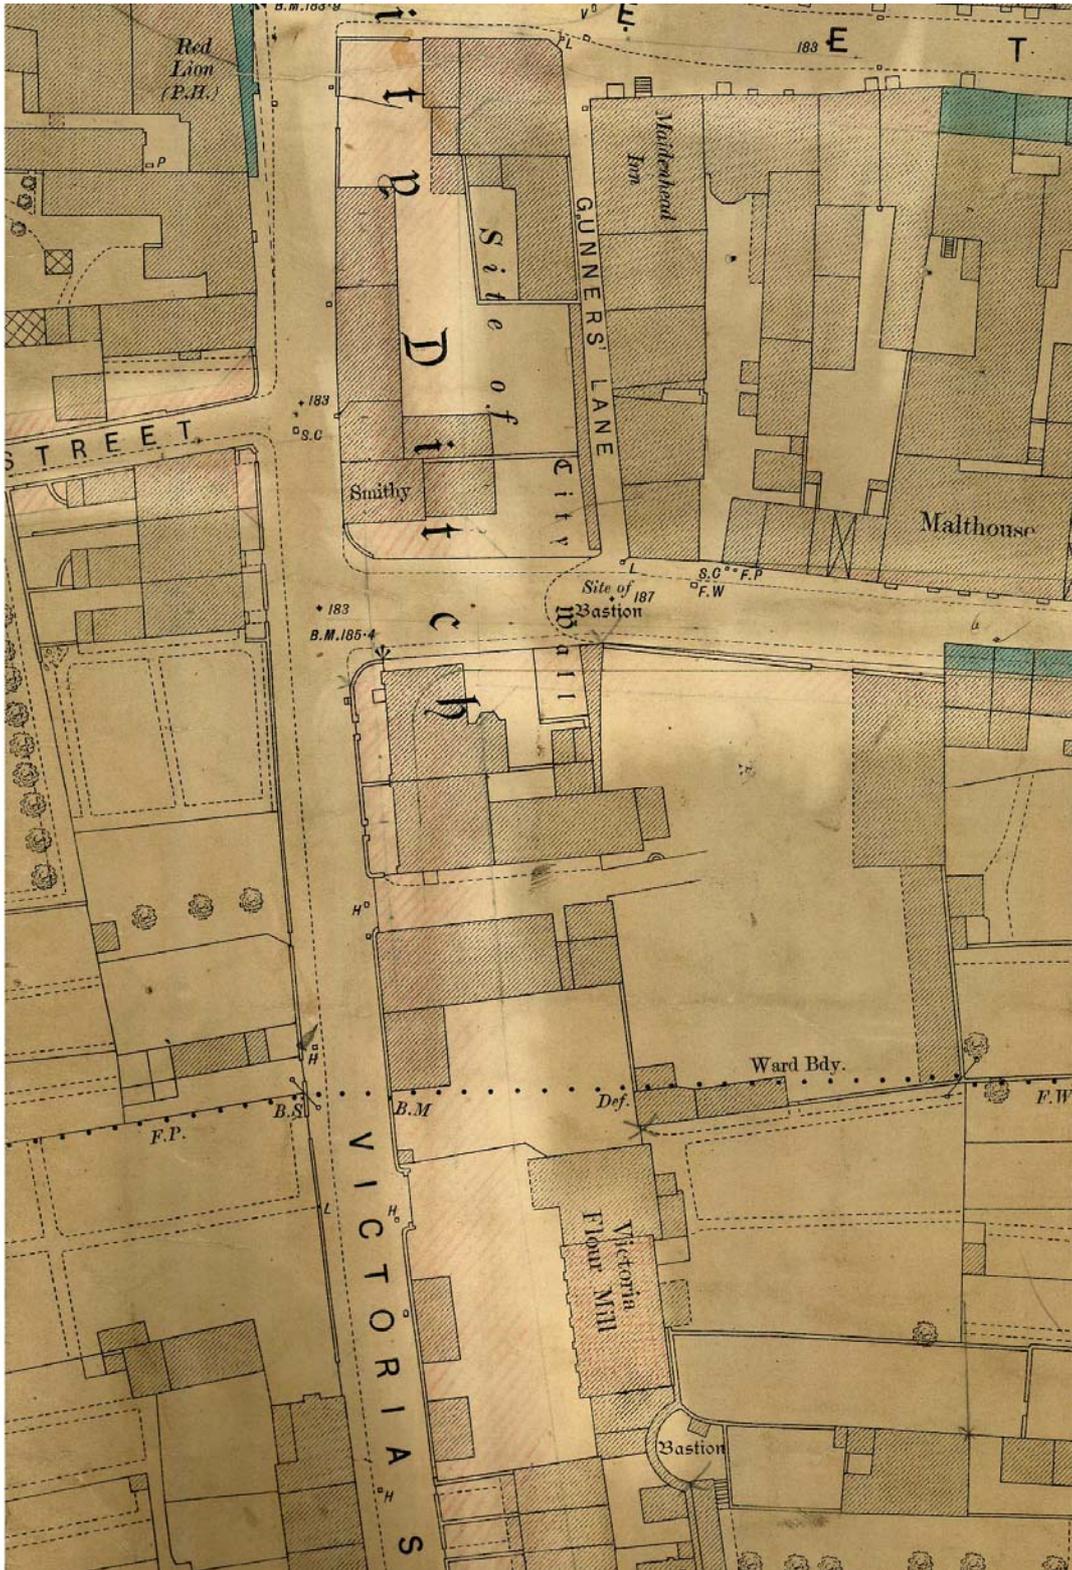
Sections 4 and 5 (Gunners Lane) as shown by the Ordnance Survey 1st edition 1:500 plan of 1886, contemporaneous with the view above. The thickened section of wall shown on the south side of West Street can be identified above and represents the pre-Conquest rampart cut by masonry retaining walls to front and back

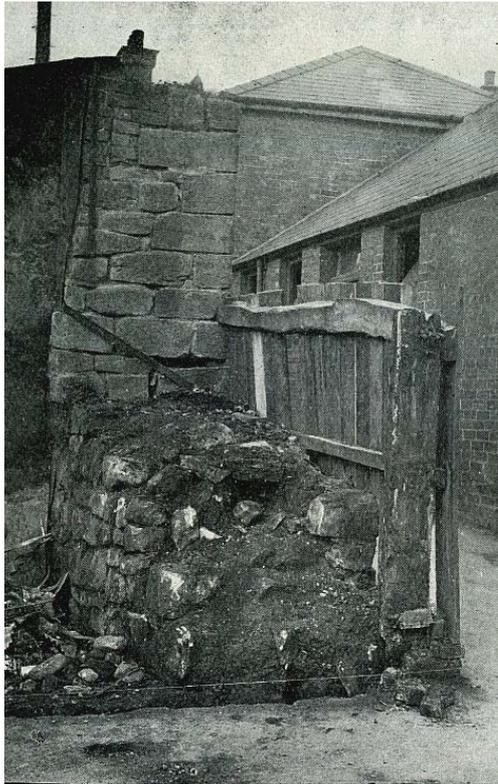
Photograph by Alfred Watkins showing the Gunners Lane wall recently truncated by the extension of West Street in the 1880s

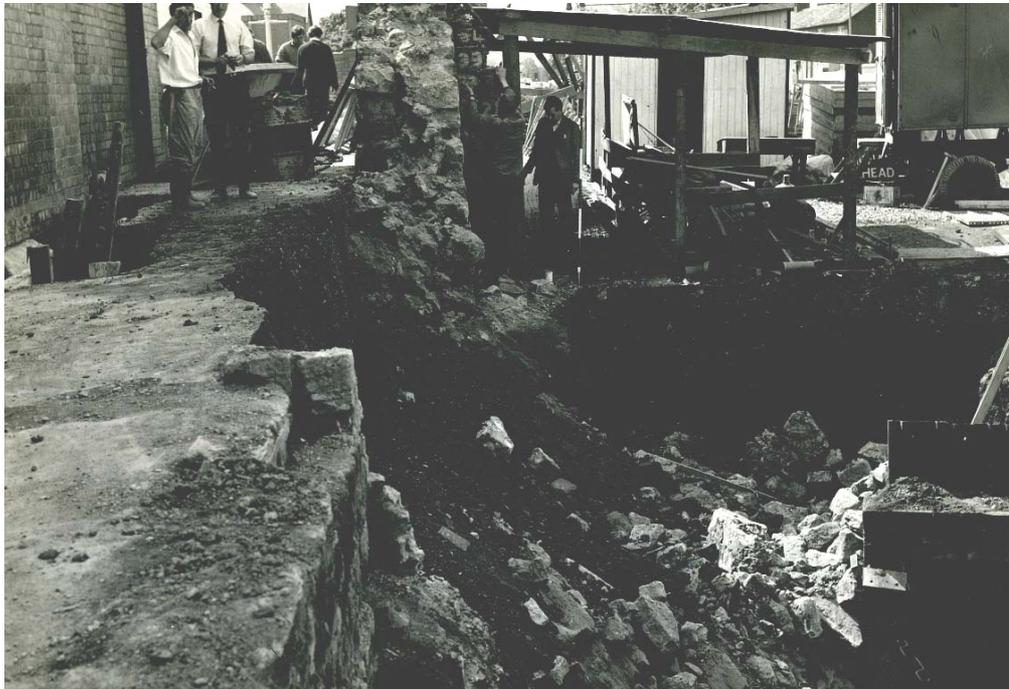
The north end of the Gunners Lane wall in 1968 following the collapse of masonry into the underpass excavations alongside (Contract photographs file, Hereford City Council)

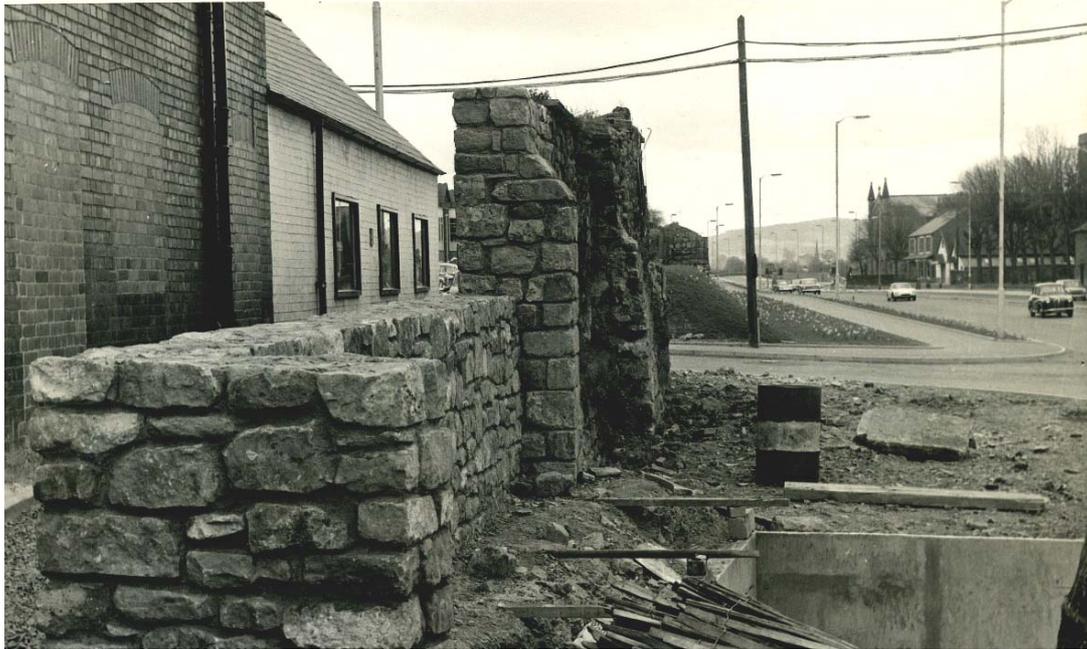
The exterior face is more complex, with at least four builds evident apart from recent repairs. At the south end, a section of random rubble 1.45m high projects c.240mm forward from the face above, which is largely composed of flattish blocks of sandstone; at the north end a similar projecting lower section is composed of large blocks of stone, contrasting with the small rubble in the top section of the wall. The wall terminates at the north end with a rebuilt vertical end bonded in with an external buttress; photographs taken in 1969 clearly show the stones of the buttress numbered for re-erection (Inner Relief Road archive file).

The north end of the Gunners Lane wall in April 1969 after reconstruction. Other photographs show the stones of the buttress (mid-foreground) numbered for dismantling (Contract photographs file, Hereford City Council)

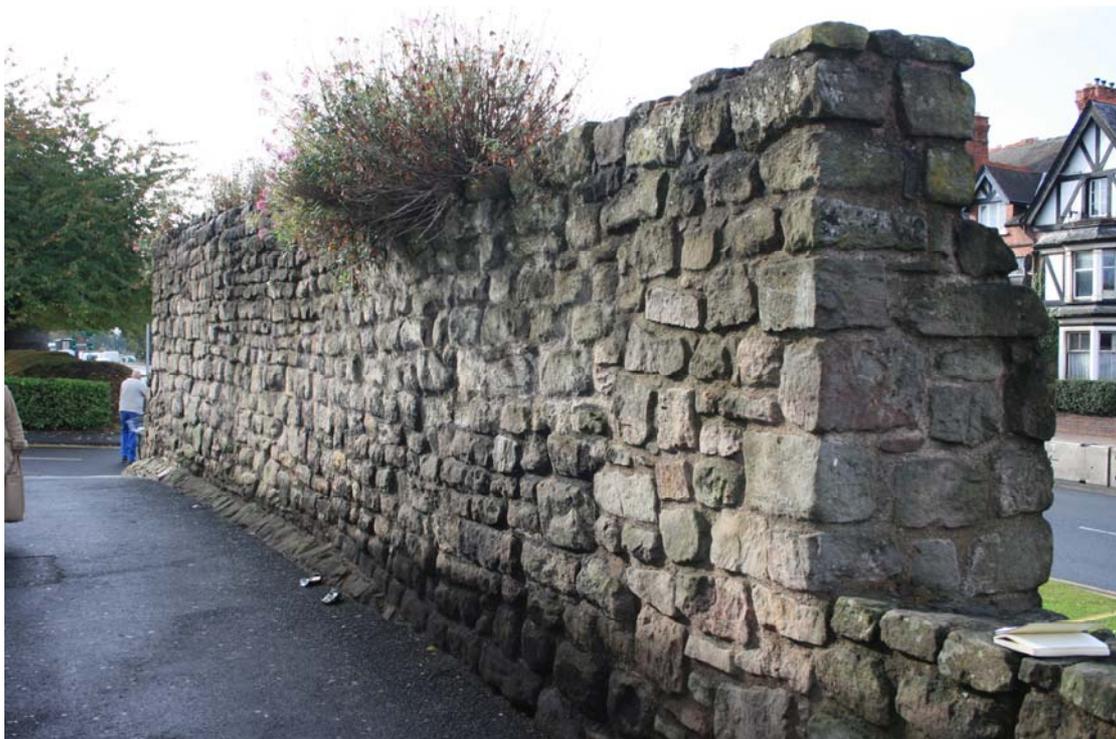
Interior face of the Gunners Lane wall, looking south

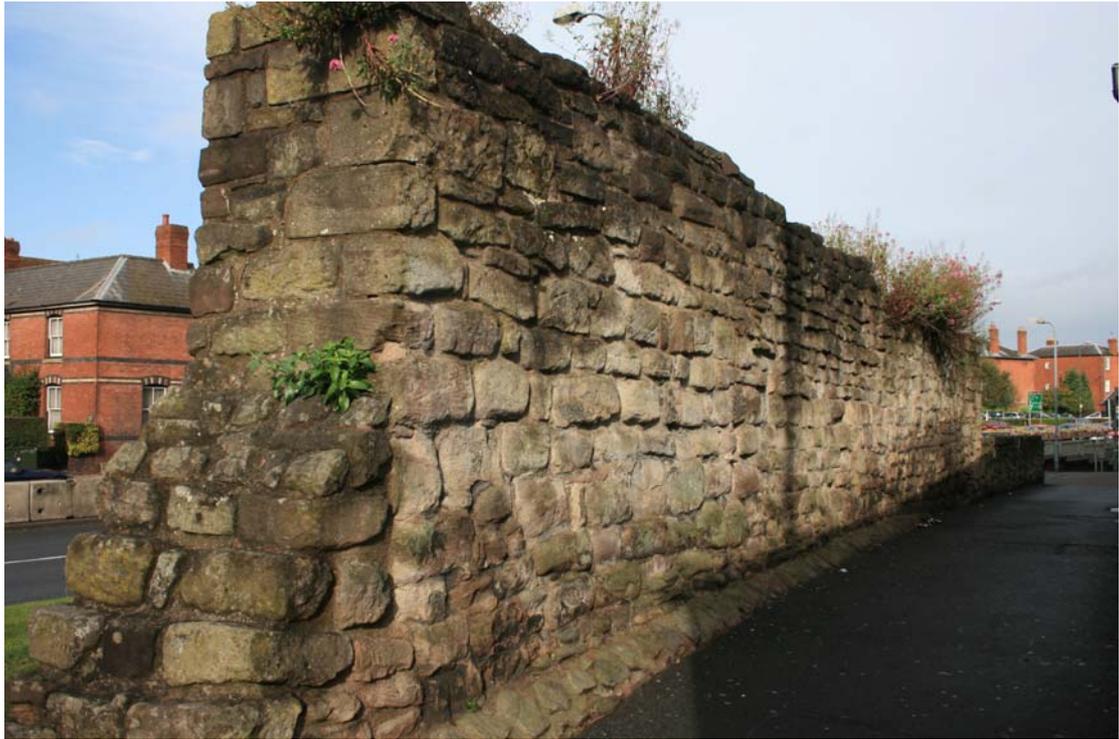
The interior face of the Gunners lane wall, looking north

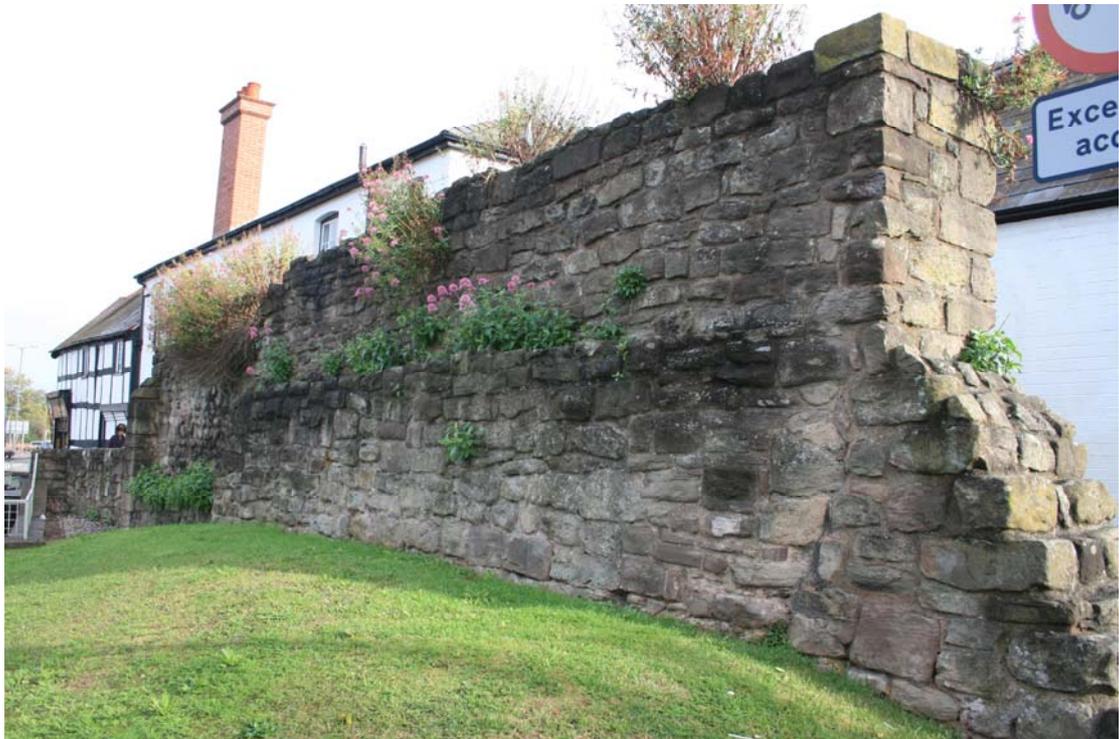
The wide joints of this section of wall are effectively if crudely pointed with a sandy mortar containing coarse (up to 3mm) grits, though the mortar has washed out of the joints at the base of the wall. Plant growth (Valerian) is fairly prolific on the exterior face, growing on the flat tops of the thickened lower sections and on the wall top and is currently (late 2010) beginning to displace mortar. The inner face is in better condition, the pointing being in a better state, with little vegetation growth.

The exterior face of the Gunners Lane wall, looking north

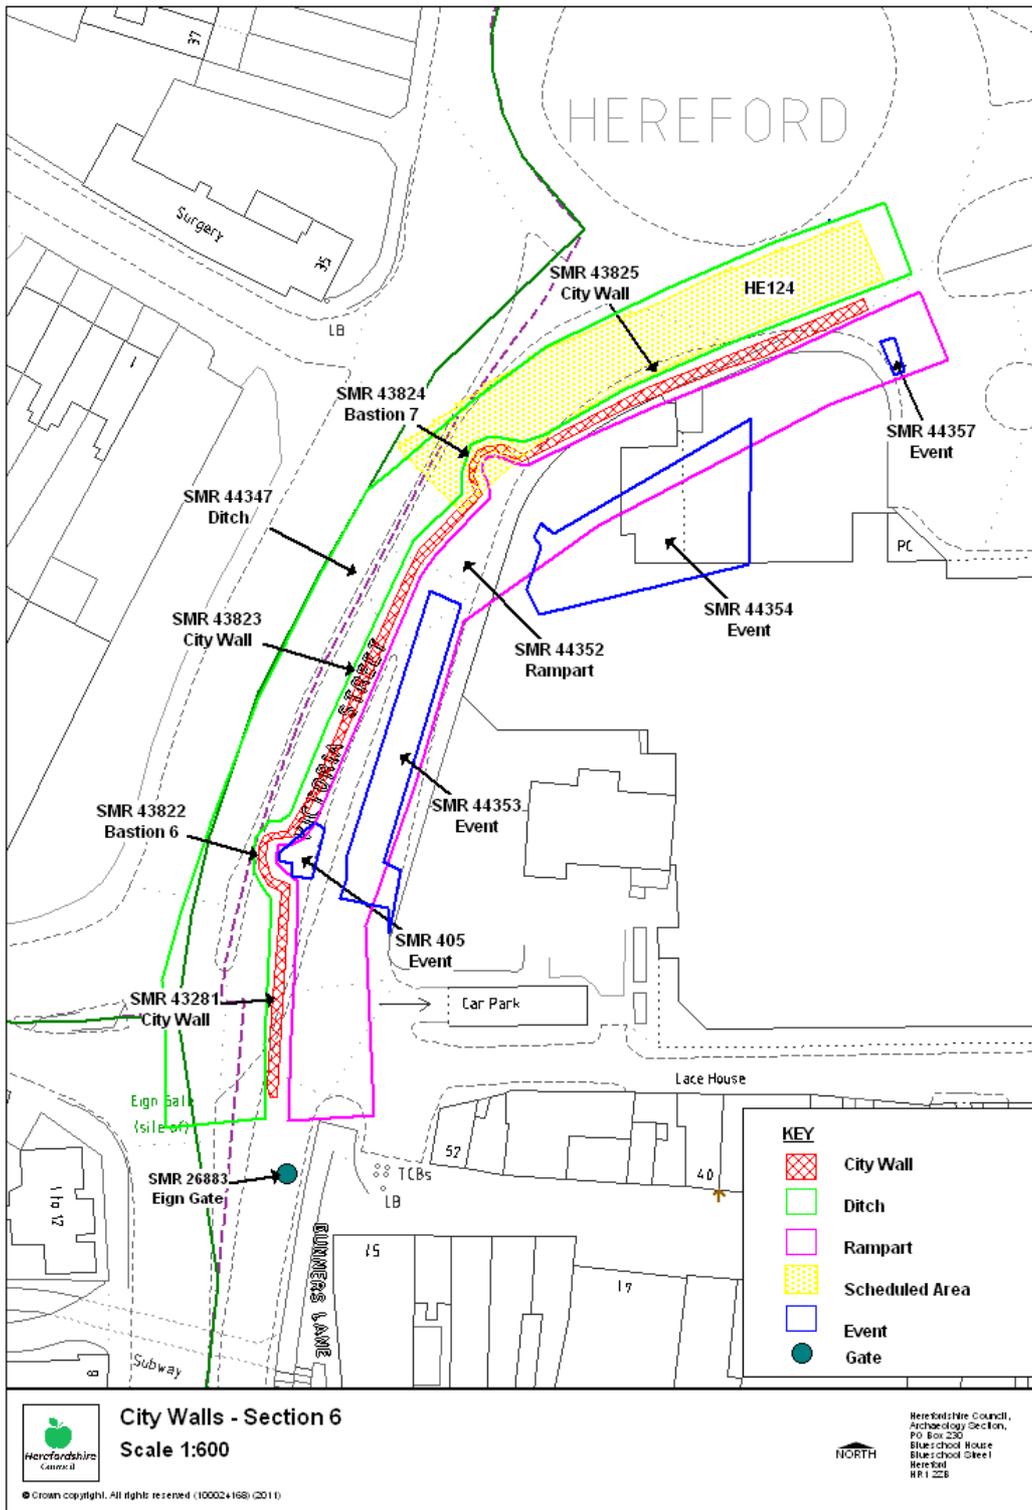
Section 6 and 7 location plan: the city wall shown in red represents the (demolished) medieval wall (section 6) and its two bastions. The present, standing 'Tesco' (reproduction) city wall (section 7) follows the curtilage boundary within this line, passing between excavation areas 44353 and 44354

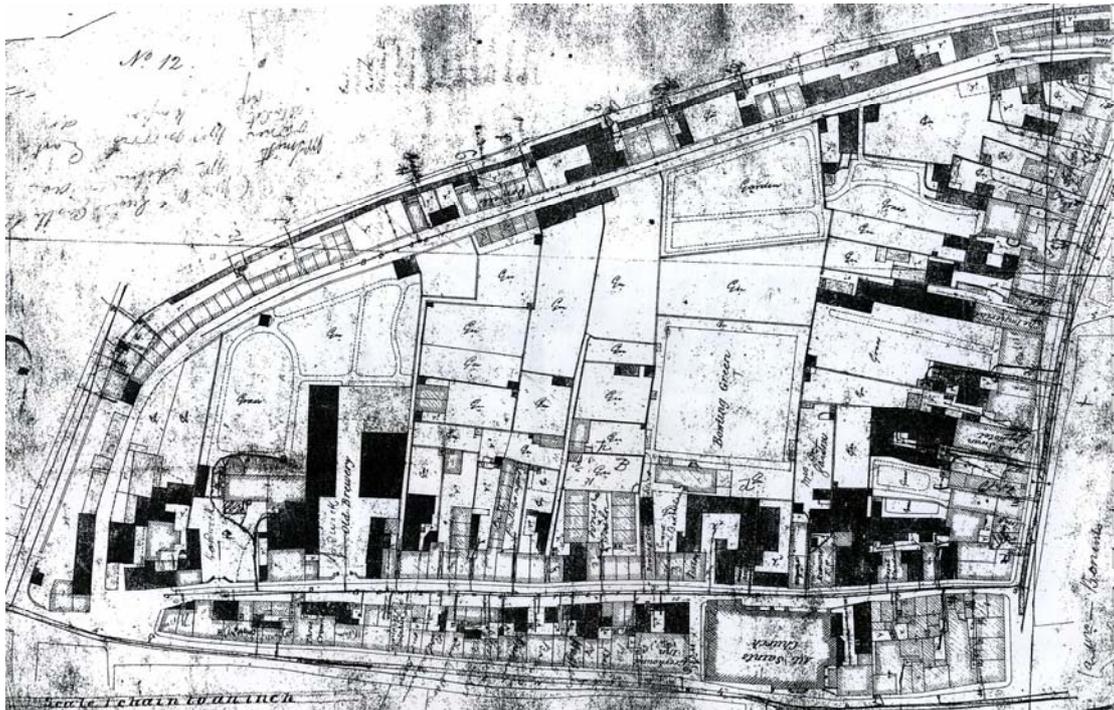
Curley's 1859 MS plan of the Wall Street quadrant of the city wall (sections 6 and 8). By this time the line of the ditch and the exterior face of the wall were almost fully built up

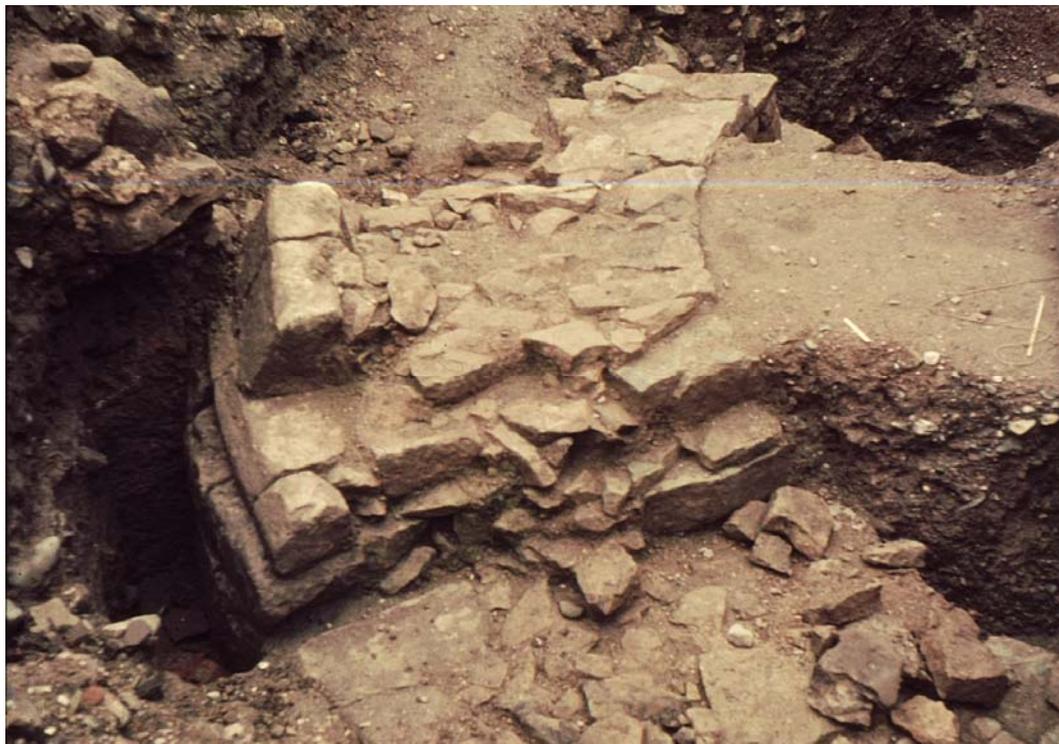
Photograph of the remains of bastion 6 under excavation in 1968; note chamfered plinth courses (for a comparison see section 16 illustrations). Photo: Ron Shoemsmith

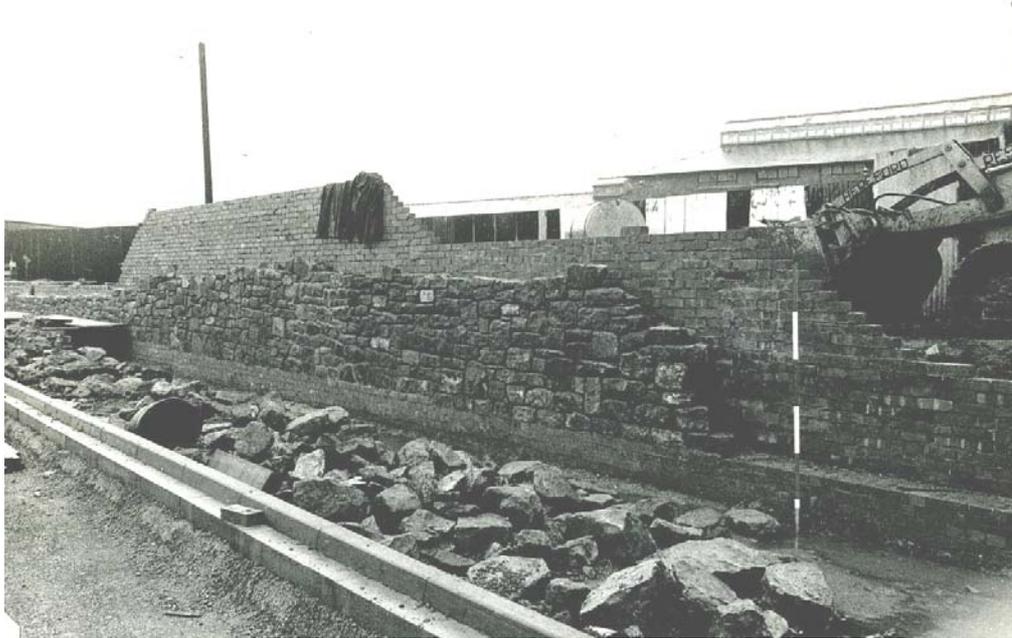
The first replacement wall under construction in October 1968, looking north-east across the site of the 1968 Brewery site excavation trench

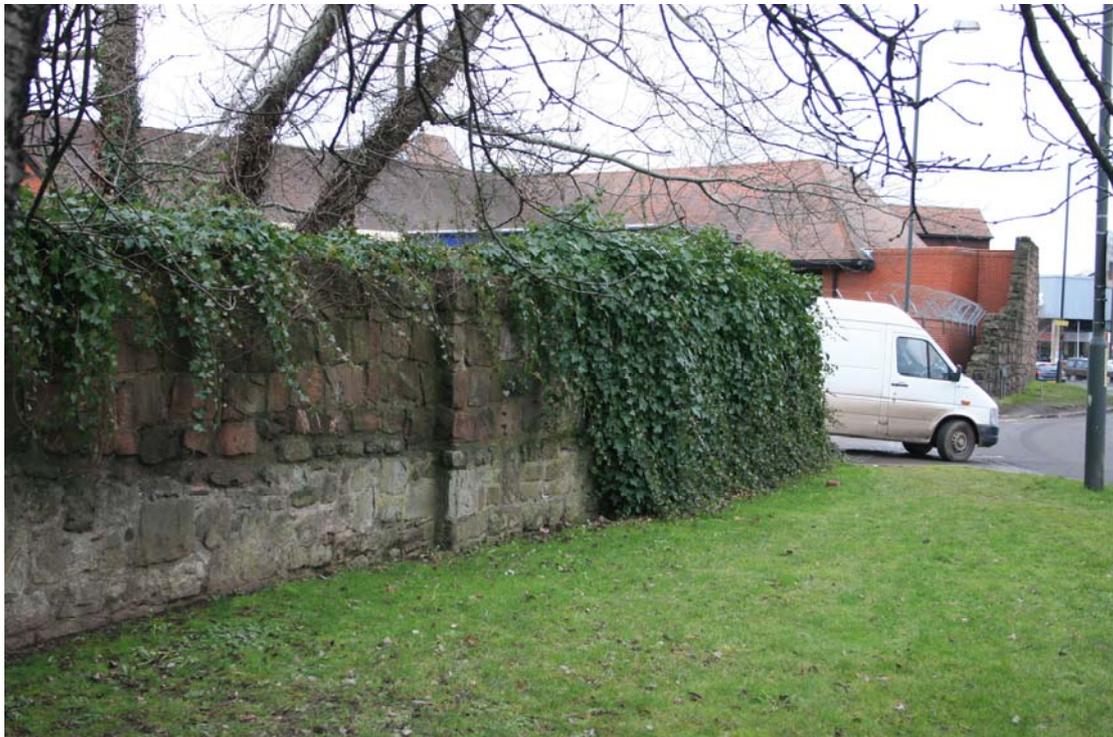
Looking west towards the north-east end of the section 7 (c.1983) wall beyond the Tesco vehicle exit. The section 8 wall in the foreground consists of base courses surviving from the 1968 wall raised by the addition of the distinctive red c.1983 Tesco-Shoesmith masonry
