Flood Investigation Report

Ross-on-Wye

12 May 2024

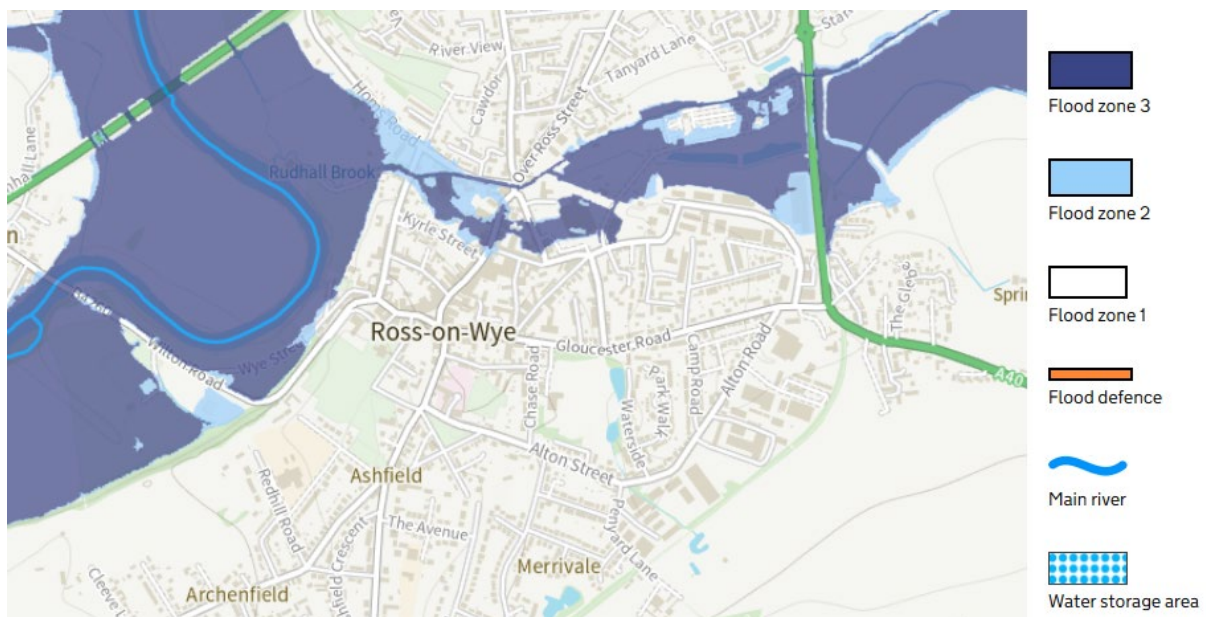
Figure 2: Environment Agency's Flood Map for Planning (Rivers and Sea).

The Flood Map for Planning shows that Brookend Street is located within Flood Zone 3 (flooding in a 100-year flood), due to the fluvial flood risk associated with Rudhall Brook. However, this flooding episode was solely due to surface water flooding; no fluvial flooding occurred at this time. Broad Street is indicated to be mostly in Flood Zone 1 (no mapped flooding) with the lower, northern end (before joining Brookend Street) located in Flood Zone 2 (flooding in a 1000-year flood). The Ross Flood Alleviation Scheme, implemented in 2008, was found to operate effectively during this event; there were no reports of flooding in the protected area.

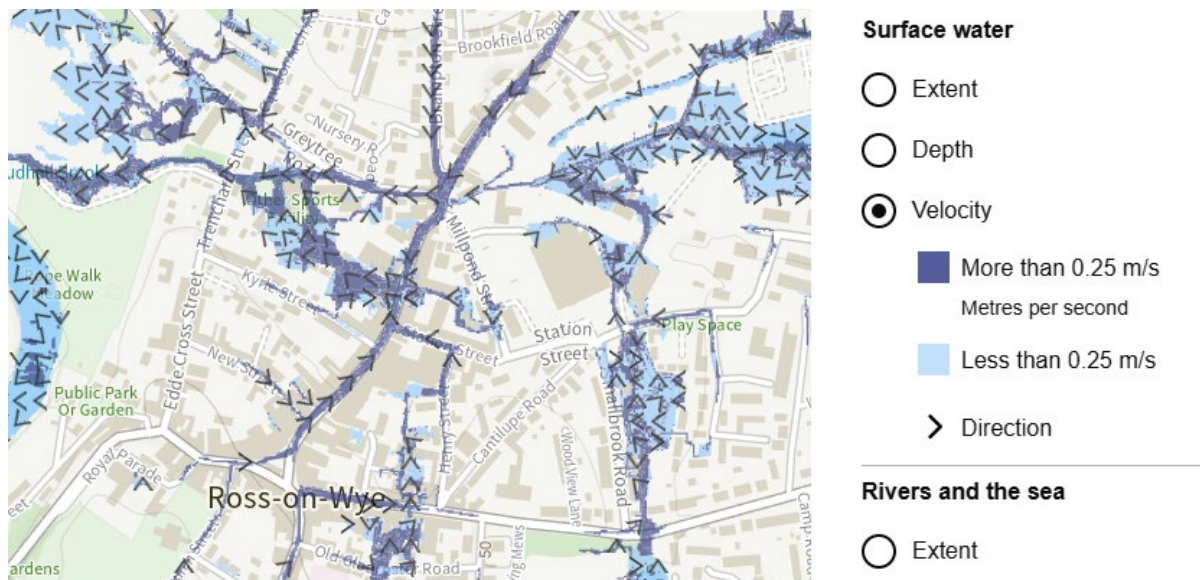
Figure 5: EA Surface Water Flood Risk Mapping showing velocity and direction of surface water flows in Ross-on-Wye (Broad Street and Brookend Street).

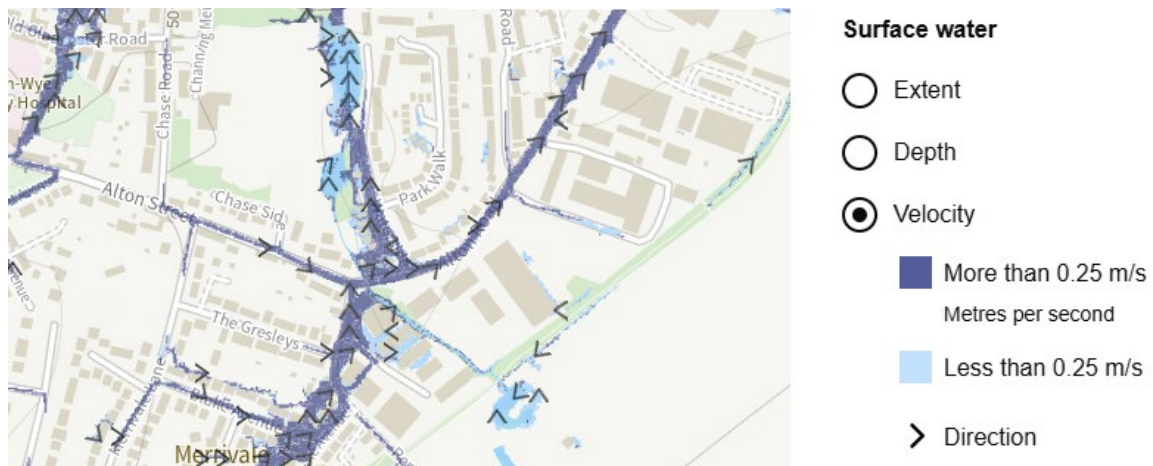
Figure 6: EA Surface Water Flood Risk Mapping showing velocity and direction of surface water flows in Ross-on-Wye (Alton Road).

The surface water runoff caused by the significant volume of rainfall within a notably short time period, in addition to the topography of the area and associated hardstanding, resulted in internal flooding to the rear of a property on Gloucester Road. A previous report of flooding is recorded on Old Gloucester Road in 2018, which was located upgradient (to the south) of the affected property on Gloucester Road. As such, it is likely that the surface water flow route continued across Old Gloucester Road before ponding at the rear of the property located on Gloucester Road (Figure 6).
