Site Address Land adjacent to The Mount

Site Area (ha) 0.27	Greenfield	✓ Agricultural Land
Potential Housing _{N/A} Capacity	Brownfield	Classification ²
Is the site suitable for development?	Is development achievable on the site	Is the site available?
Yes 🗆	Yes 🗌	Yes 🗌
No 🔽	No 🖌	No
Part	Part	Don't Know 🔽
Possible timescale for develop	pment?	
1-5 Years	11-15 Years	Not In Current Plan Period
6-10 Years	16-20 Years

Settlement Name Llangrove

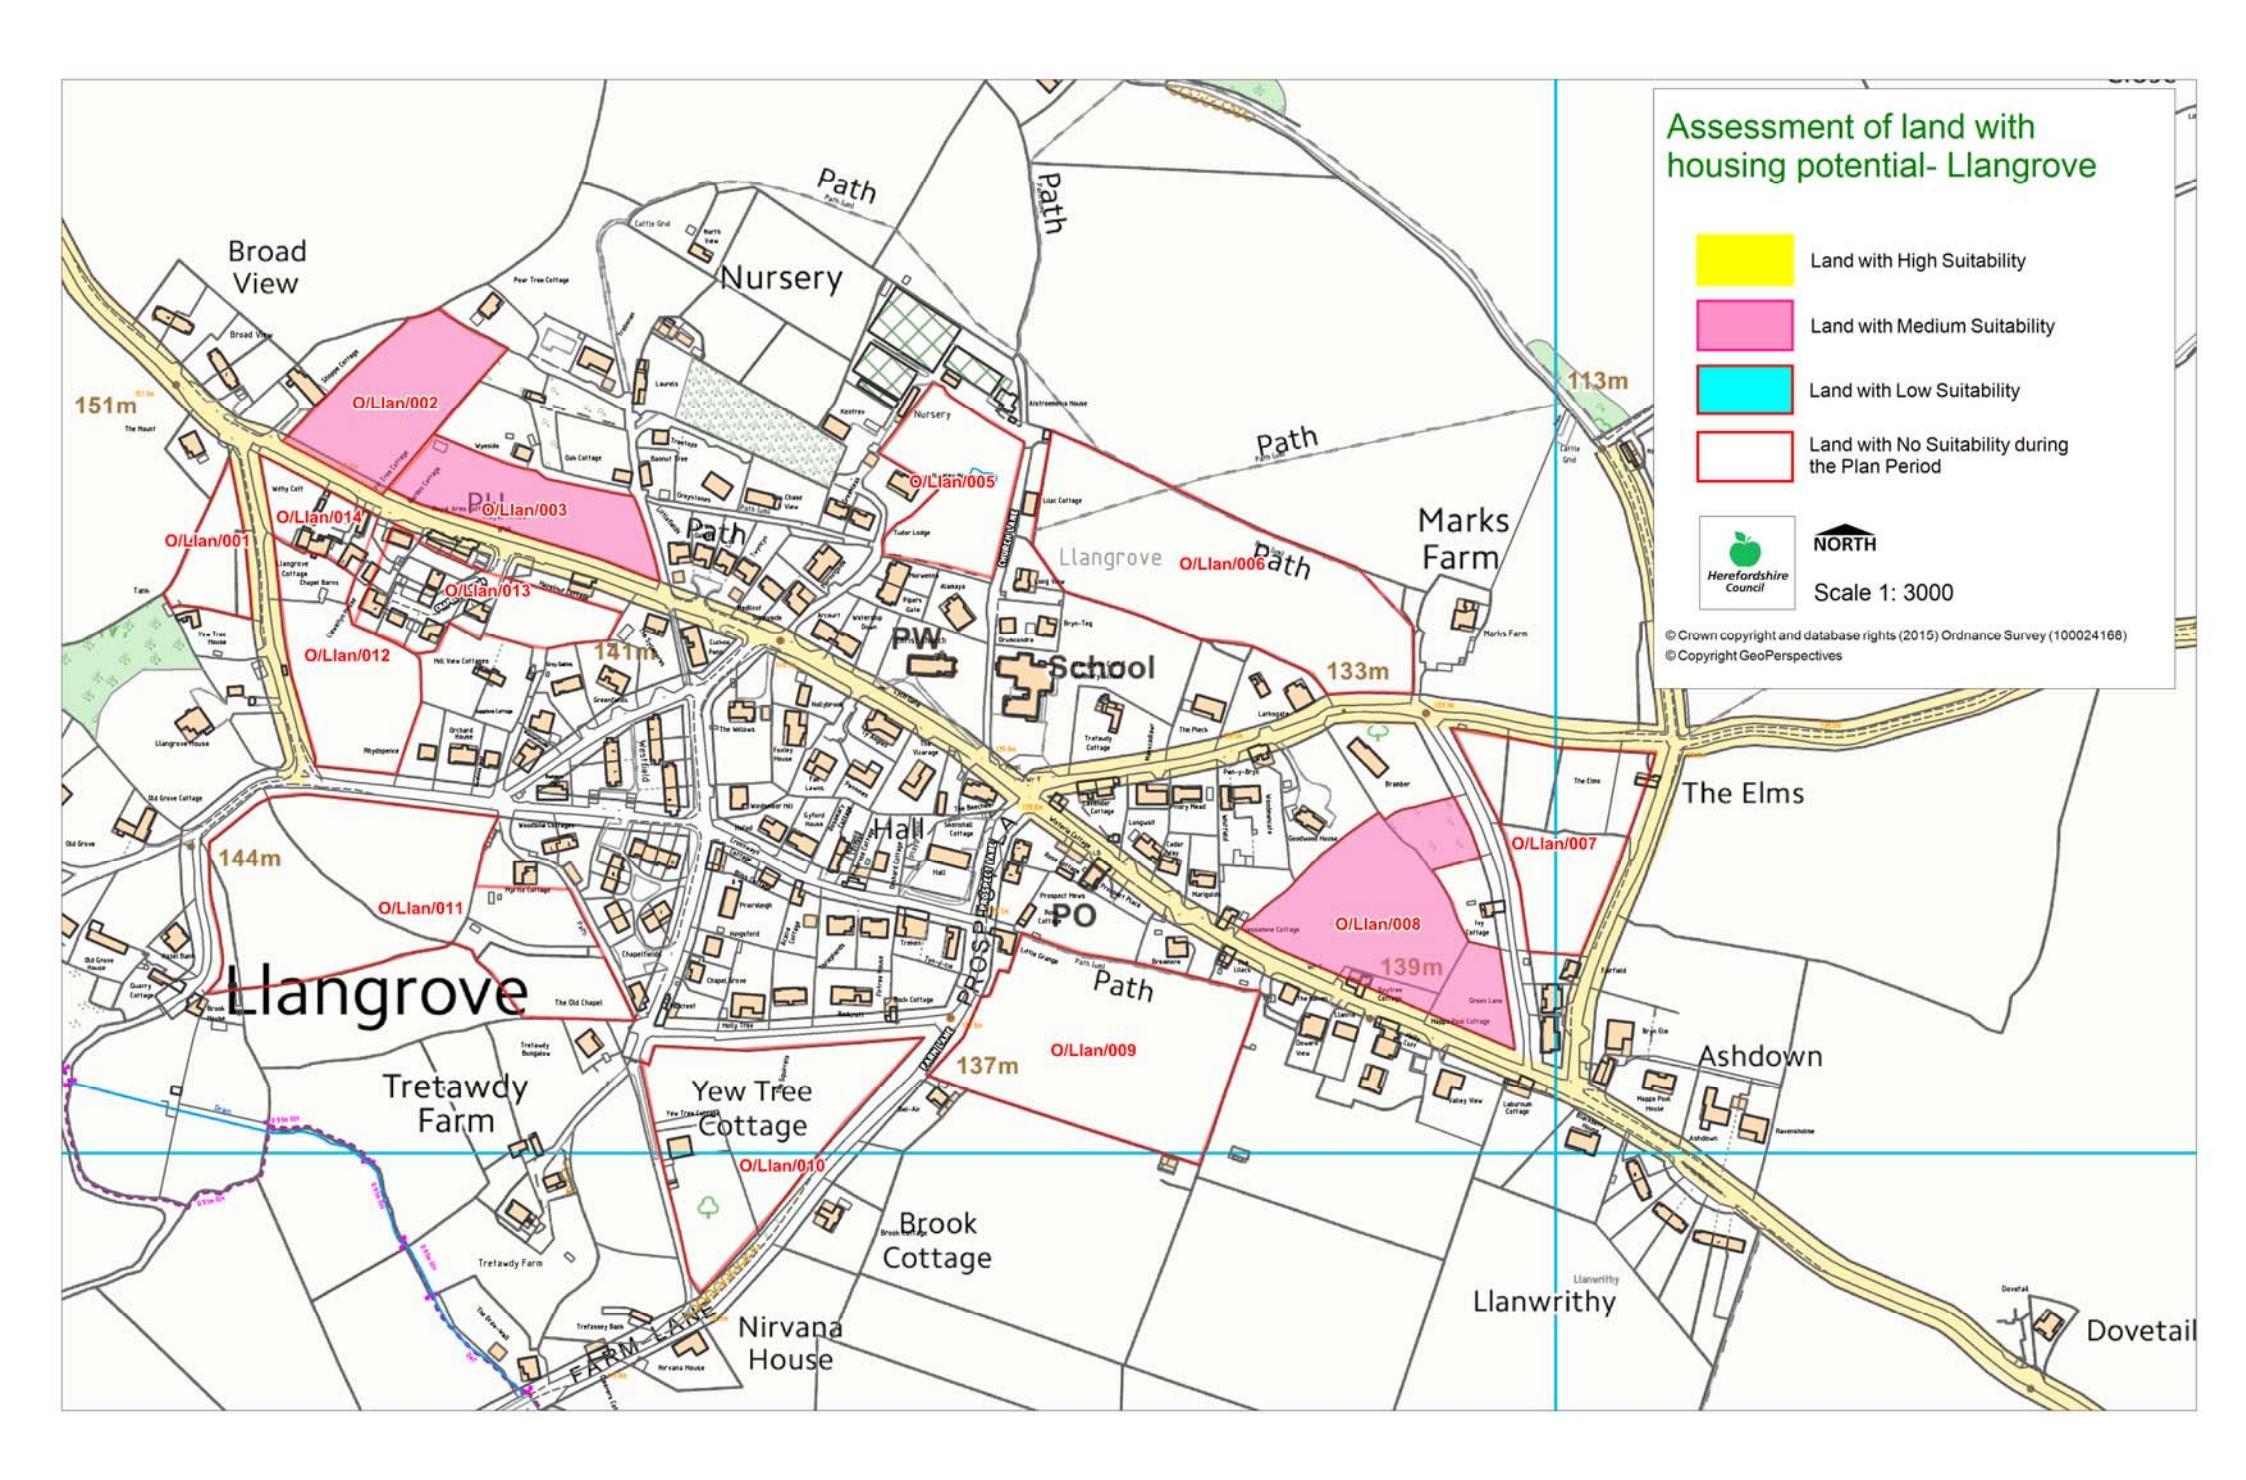
Site Address Land adjacent to Chapel Meadow

Sensitivity & Capacity Analysis: An enclosed site with a hedgerow adjacent to the road. It is weed infested and overgrown; with a derelict appearance.

The site has planning permission (P150911/F) - 6 HOUSES - 27/03/15- Rear of Hazlenut Cottage. No further capacity on this site.
